Access Compliance Report Public Rights-of-Way (Curb Ramps)

Intersection ID: 2896Main Street:ALLNESS_GLEN_LNCross Street:HARBURN_FOREST_DRLocation:SWADA ID: 6F3A9AEB297DRamp Type:PerpDiagInitial Pass/Fail:FailOverall Compliance:NoSeverity Score:35

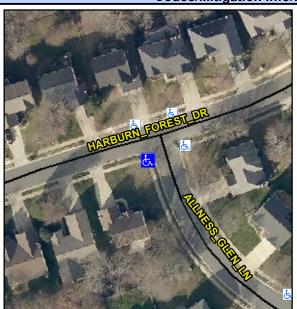
Not Found, R304.5.1, R304.2.2, R304.5.3

Compliance Description Data Compliance Description Data No N/A Ramp Length (in) 43.5 Ramp Slope (%) 12.6 No No Ramp Width (in) 47.0 Ramp XSlope (%) 4.7 N/A N/A Flare Type LT N/A Flare Type RT N/A N/A N/A N/A Flare Slope RT (%) N/A Flare Slope LT (%) N/A Flare Traversable LT? N/A N/A Flare Traversable RT? N/A N/A N/A N/A DWS Provided? N/A Landing Length (in) N/A Landing Width (in) N/A N/A **DWS Contrast?** N/A N/A N/A N/A Landing Slope (%) DWS Length (in) N/A N/A Landing X Slope (%) N/A N/A DWS Full Width? N/A N/A Landing Curb? (Y/N) N/A N/A DWS Offset (in) N/A N/A N/A Shared Landing? N/A **Gutter Ponding?** N/A N/A Gutter Slope (%) N/A N/A Gutter Lip Ht (in) N/A N/A Gutter X Slope (%) N/A N/A Painted X Walk1? No N/A Painted X Walk2? No X Walk 1 Direction To E X Walk 2 Direction To N N/A N/A X Walk 1 Width (in) X Walk 2 Width (in) N/A X Walk 1 Slope (%) 2.8 X Walk 2 Slope (%) 2.9 X Walk 1 X Slope (%) 3.6 X Walk 2 X Slope (%) 1.4 N/A N/A N/A Ramp inside XWalk2? N/A Ramp inside XWalk1? Road Slope (%) 3.0 N/A Clear Space? N/A N/A Road X Slope (%) 1.5 Clear Space to XWalk (in) N/A N/A N/A N/A Any Obstructions? Storm Grate/Utility Hazard? N/A **Obstruction Type** Storm Grate/Utility Type N/A N/A Yes Surface Condition? (G/P) Good

Remove & Replace Curb Ramp With Two New Directional Ramps or Equivalent.
