Access Compliance Report

Public Rights-of-Way

(Curb Ramps)

Intersection ID: 10029517	Main Street: KENTLAND_LN	Cross Street: FLAGSTAFF_DR	Location:	E
ADA ID: 6F4098FBDCF6	Ramp Type: Combination1Diag	Initial Pass/Fail: Fail	Overall Compliance: No	Severity Score: 0

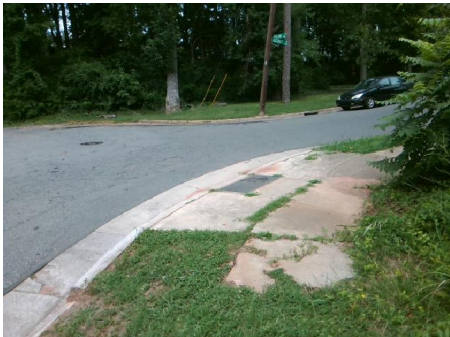
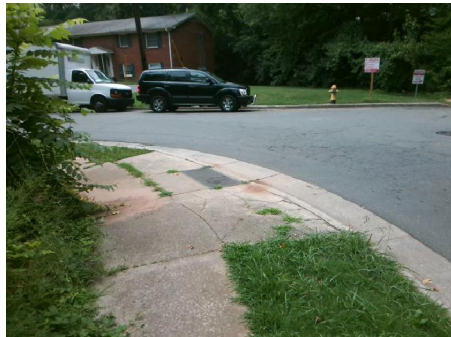
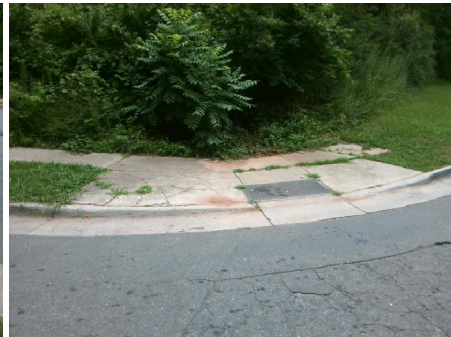
Possible Solutions:			Compliance	Description	Data	Compliance	Description	Data
	Remove & Replace Curb Ramp With Two New Directional Ramps or Equivalent.			N/A	Ramp Length LT (in)	83.0	N/A	Ramp Length RT (in)	N/A
				Yes	Ramp Width LT (in)	49.0	N/A	Ramp Width RT (in)	N/A
				No	Ramp Slope LT (%)	8.6	N/A	Ramp Slope RT (%)	N/A
				No	Ramp XSlope LT (%)	3.3	N/A	Ramp XSlope RT (%)	N/A
				N/A	Ramp Length (in)	55.0	Yes	Ramp Slope (%)	7.1
				Yes	Ramp Width (in)	49.0	Yes	Ramp XSlope (%)	0.9
	Surveyor Notes:			N/A	Flare Type LT	N/A	N/A	Flare Type RT	N/A
	N/A			N/A	Flare Slope LT (%)	N/A	N/A	Flare Slope RT (%)	N/A
				N/A	Flare Traversable LT?	N/A	N/A	Flare Traversable RT?	N/A
PROW/ADA:			N/A	Landing Length (in)	N/A	N/A	DWS Provided?	N/A	
Not Found, R304.3.2, R304.5.3			N/A	Landing Width (in)	N/A	N/A	DWS Contrast?	N/A	
			N/A	Landing Slope (%)	N/A	N/A	DWS Length (in)	N/A

N/A	Landing X Slope (%)	N/A	N/A	DWS Full Width?	N/A	
			N/A	Landing Curb? (Y/N)	N/A	N/A	DWS Offset (in)	N/A	
			N/A	Shared Landing?	N/A				
			N/A	Gutter Ponding?	N/A	N/A	Gutter Slope (%)	N/A	
			N/A	Gutter Lip Ht (in)	N/A	N/A	Gutter X Slope (%)	N/A	
			N/A	Painted X Walk1?	No	N/A	Painted X Walk2?	No	
				X Walk 1 Direction	To NW		X Walk 2 Direction	To SW	
				X Walk 1 Width (in)	N/A		X Walk 2 Width (in)	N/A	
				X Walk 1 Slope (%)	3.1		X Walk 2 Slope (%)	1.1	
				X Walk 1 X Slope (%)	2.0		X Walk 2 X Slope (%)	3.3	
Total Cost:			N/A	Ramp inside XWalk1?	N/A	N/A	Ramp inside XWalk2?	N/A	
				Road Slope (%)	1.1		Clear Space?	N/A	
				Road X Slope (%)	1.4	N/A	Clear Space to XWalk (in)	N/A	
						N/A	Any Obstruction?	N/A	
							Obstruction Type	N/A	
						N/A	Storm Grate/Utility Hazard?	N/A	
							Storm Grate/Utility Type	N/A	
			Yes	Surface Condition? (G/P)				N/A	
				Curb Slope (%)				Good
