# Access Compliance Report

## Public Rights-of-Way

### (Curb Ramps)

| Intersection ID: 10257 | Main Street: E_36TH_ST | Cross Street: N_MCDOWELL_ST | Location: N |

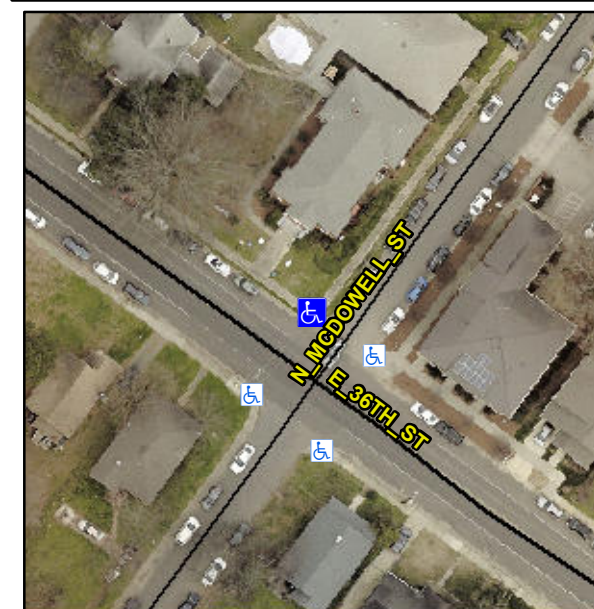
| ADA ID: 6F9AA77B847A | Ramp Type: PerpDiag | Initial Pass/Fail: Fail | Overall Compliance: No |
| Severity Score: 12.5 | | | |

**Not Found, R304.2.2**

| Compliance | Description | Data | Compliance | Description | Data |
|---|---|---|---|---|---|
| N/A | Ramp Length (in) | 70.0 | No | Ramp Slope (%) | 8.7 |

**Remove & Replace Curb Ramp With Two New Directional Ramps or Equivalent.**

Total Cost: \$ 3200.00
