Access Compliance Report Public Rights-of-Way (Curb Ramps)

Intersection ID: 28112Main Street:PROVIDENCE_RDCross Street:BELICOURT_DRLocation:NEADA ID: 6FDADD5155D2Ramp Type:ParaInitial Pass/Fail:FailOverall Compliance:NoSeverity Score:12.5

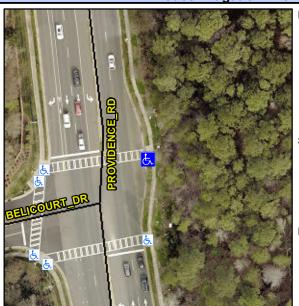
RT RP < 5%

R304.3.2

| Compliance Description Date | | | Compliance Description | | Data |
|---|---|---|---|---|---|
| No | Ramp Slope LT (%) | 11.6 | Yes | Ramp Slope RT (%) | 1.7 |

Remove & Replace Entire Ramp.
