Access Compliance Report

Public Rights-of-Way

(Curb Ramps)

Intersection ID: 46913	Main Street: PONDEROSA_PINE_LN	Cross Street: PINYON_PINE_LN	Location: S
ADA ID: 70336E143A49	Ramp Type: PerpDiag	Initial Pass/Fail: Fail	Overall Compliance: No
		Severity Score: 25

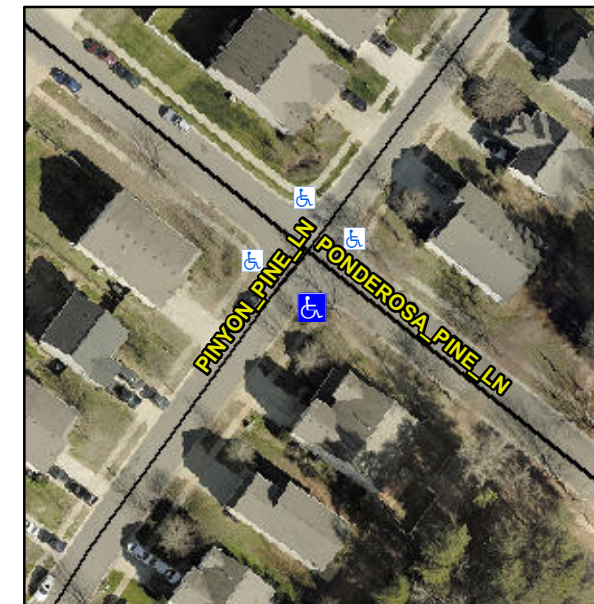
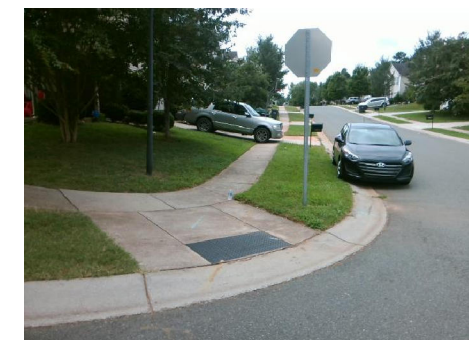
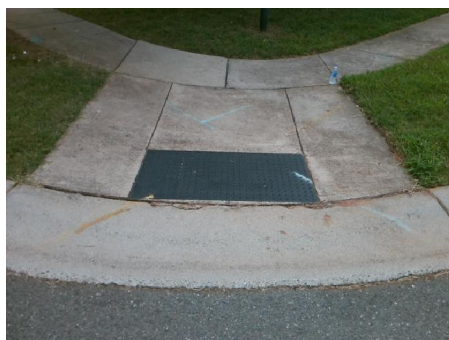
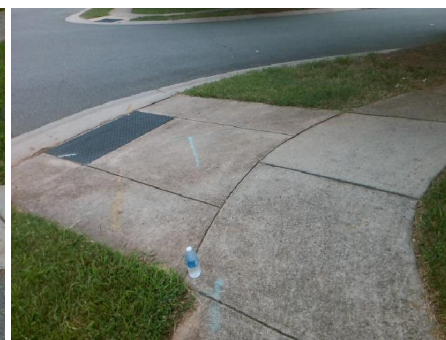
Not Found, R304.5.3

Compliance	Description	Data	Compliance	Description	Data
N/A	Ramp Length (in)	83.5	Yes	Ramp Slope (%)	7.3
Yes	Ramp Width (in)	48.0	No	Ramp XSlope (%)	9.3
N/A	Flare Type LT	N/A	N/A	Flare Type RT	N/A
N/A	Flare Slope LT (%)	N/A	N/A	Flare Slope RT (%)	N/A
N/A	Flare Traversable LT?	N/A	N/A	Flare Traversable RT?	N/A
N/A	Landing Length (in)	N/A	N/A	DWS Provided?	N/A
N/A	Landing Width (in)	N/A	N/A	DWS Contrast?	N/A
N/A	Landing Slope (%)	N/A	N/A	DWS Length (in)	N/A
N/A	Landing X Slope (%)	N/A	N/A	DWS Full Width?	N/A
N/A	Landing Curb? (Y/N)	N/A	N/A	DWS Offset (in)	N/A
N/A	Shared Landing?	N/A			
N/A	Gutter Ponding?	N/A	N/A	Gutter Slope (%)	N/A
N/A	Gutter Lip Ht (in)	0.5	N/A	Gutter X Slope (%)	N/A
N/A	Painted X Walk1?	No	N/A	Painted X Walk2?	No
	X Walk 1 Direction	To NE		X Walk 2 Direction	To NW
N/A	X Walk 1 Width (in)	N/A	N/A	X Walk 2 Width (in)	N/A
	X Walk 1 Slope (%)	4.2		X Walk 2 Slope (%)	1.1
	X Walk 1 X Slope (%)	4.8		X Walk 2 X Slope (%)	3.4

Remove & Replace Curb Ramp With Two New Directional Ramps or Equivalent.
