## Access Compliance Report Public Rights-of-Way (Curb Ramps)

Internection ID: 47976 Mein Street: MADVANNA CT									Location:	Е	
Intersection ID: 47876	: 47876 Main Street: MARYANNA_CT		CIUSS	Cross Street: WOODSORREL_LN					<u> </u>		
ADA ID: 70AEFEEAA3DB Ramp Type: PerpDiag			Initial	Initial Pass/Fail: Fail Overall Compliance: No				o Severity Score:	10		
Codes/Mitigation Info/Possible Solution					Field Measurements/Component Compliance						
	AL MASS	Possible Solutions:			Compliance Description		Data Complia		ance Description	Data

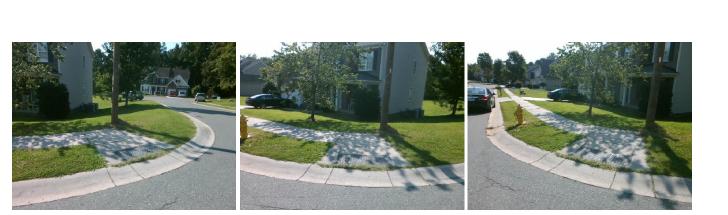
1. 1.	Remove & Replace Curb	Ram	o With	N/A	Ramp Length (in)	49.0	Yes	Ramp Slope (%)	5.1	
		Two New Directional R	•		No	Ramp Width (in)	47.2	No	Ramp XSlope (%)	3.1	
		Equivalent.			N/A	Flare Type LT	N/A	N/A	Flare Type RT	N/A	
	Co Y				N/A	Flare Slope LT (%)	N/A	N/A	Flare Slope RT (%)	N/A	
di la	42				N/A	Flare Traversable LT?	N/A	N/A	Flare Traversable RT?	N/A	
6 Susalitation					N/A	Landing Length (in)	N/A	N/A	DWS Provided?	N/A	
		Surveyor Notes:			N/A	Landing Width (in)	N/A	N/A	DWS Contrast?	N/A	
the second se	$\mathbf{A}$	N/A			N/A	Landing Slope (%)	N/A	N/A	DWS Length (in)	N/A	
	4 90				N/A	Landing X Slope (%)	N/A	N/A	DWS Full Width?	N/A

C. Martin	All and the				N/A	Landing Curb? (Y/N)	N/A	N/A	DWS Offset (in)	N/A	
A CARLER CONTRACTOR					N/A	Shared Landing?	N/A				
5		PROW/ADA:			N/A	Gutter Ponding?	N/A	N/A	Gutter Slope (%)	N/A	
		Not Found, R304.5.1, R3	04.5.3	3	N/A	Gutter Lip Ht (in)	N/A	N/A	Gutter X Slope (%)	N/A	
	1	,,,			N/A	Painted X Walk1?	No	N/A	Painted X Walk2?	No	
A A A A A A A A A A A A A A A A A A A						X Walk 1 Direction	To SW		X Walk 2 Direction	To NW	
					N/A	X Walk 1 Width (in)	N/A	N/A	X Walk 2 Width (in)	N/A	
Street 1 Name WOODS	ORREL LN	-				X Walk 1 Slope (%)	2.3		X Walk 2 Slope (%)	5.2	
Stop Condition-Street 2	None					X Walk 1 X Slope (%)	5.9		X Walk 2 X Slope (%)	1.7	
Street 2 Name MAR	RYANNA CT				N/A	Ramp inside XWalk1?	N/A	N/A	Ramp inside XWalk2?	N/A	
Stop Condition-Street 1	StopSign					Road Slope (%)	3.8	N/A	Clear Space?	N/A	
						Road X Slope (%)	5.9	N/A	Clear Space to XWalk (in)	N/A	
					N/A	Any Obstructions?	N/A	N/A	Storm Grate/Utility Hazard?	N/A

Total Cost:	\$	3200.00		Obstruction Type			Storm Grate/Utility Type		
							N/A			N/A
