Access Compliance Report Public Rights-of-Way (Curb Ramps)

Intersection ID: 15763 Main Street: MONROE_RD Cross Street: N_WENDOVER_RD Location: NW

ADA ID: 70F634E7CA3A Ramp Type: Perp Initial Pass/Fail: Fail Overall Compliance: No Severity Score: 8.75

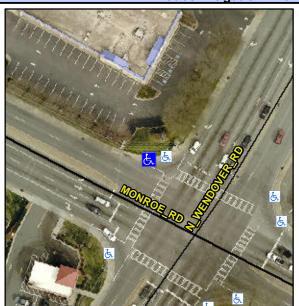
. Cocibie Colution	
Possible Solutions:	Con
Remove & Replace Entire Ramp.	N/A
	No
	N/A
	N/A
	N/A
	N/A
Surveyor Notes:	N/A
N/A	N/A
	N/A
	N/A
	N/A
PROW/ADA:	N/A
Not Found, R304.5.1	N/A
·	N/A
	N/A
	N/A

Field Measurements/Component Compliance							
Comp	liance Description	Data	Comp	liance Description	Data		
N/A	Ramp Length (in)	59.0	Yes	Ramp Slope (%)	8.0		
No	Ramp Width (in)	44.0	Yes	Ramp XSlope (%)	0.5		
N/A	Flare Type LT	N/A	N/A	Flare Type RT	N/A		
N/A	Flare Slope LT (%)	N/A	N/A	Flare Slope RT (%)	N/A		
N/A	Flare Traversable LT?	N/A	N/A	Flare Traversable RT?	N/A		
N/A	Landing Length (in)	N/A	N/A	DWS Provided?	N/A		
N/A	Landing Width (in)	N/A	N/A	DWS Contrast?	N/A		
N/A	Landing Slope (%)	N/A	N/A	DWS Length (in)	N/A		
N/A	Landing X Slope (%)	N/A	N/A	DWS Full Width?	N/A		
N/A	Landing Curb? (Y/N)	N/A	N/A	DWS Offset (in)	N/A		
N/A	Shared Landing?	N/A					
N/A	Gutter Ponding?	N/A	N/A	Gutter Slope (%)	N/A		
N/A	Gutter Lip Ht (in)	N/A	N/A	Gutter X Slope (%)	N/A		
N/A	Painted X Walk1?	Yes	N/A	Painted X Walk2?	N/A		
	X Walk 1 Direction	To SW		X Walk 2 Direction	N/A		
N/A	X Walk 1 Width (in)	107.0	N/A	X Walk 2 Width (in)	N/A
