# Access Compliance Report

## Public Rights-of-Way

### (Curb Ramps)

Intersection ID: 44306	Main Street: MALLORY_TAYLOR_LN	Cross Street: LINDA_VISTA_LN	Location: NE
ADA ID: 70F7390F59E9	Ramp Type: PerpDiag	Initial Pass/Fail: Fail	Overall Compliance: No
Severity Score: 10			
Codes/Mitigation Info/Possible Solution		Field Measurements/Component Compliance

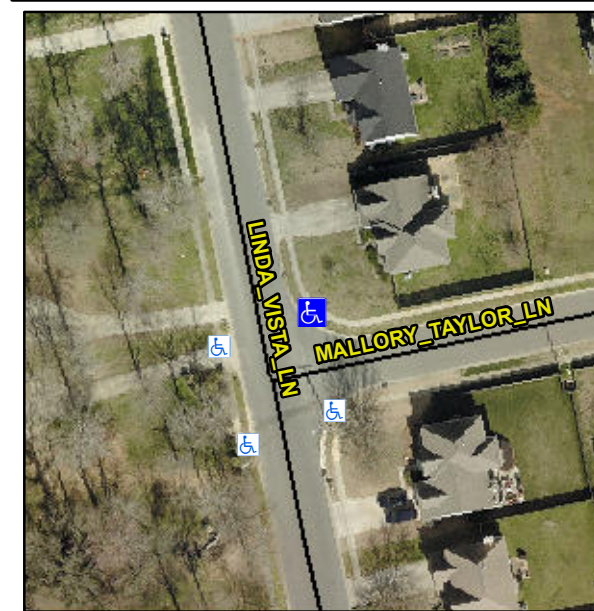
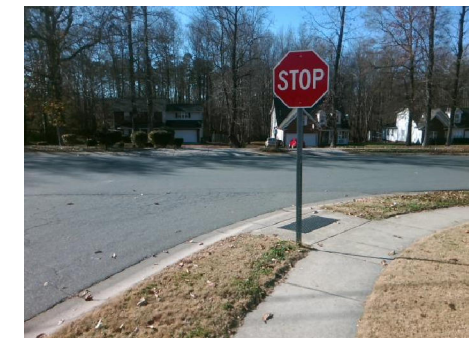
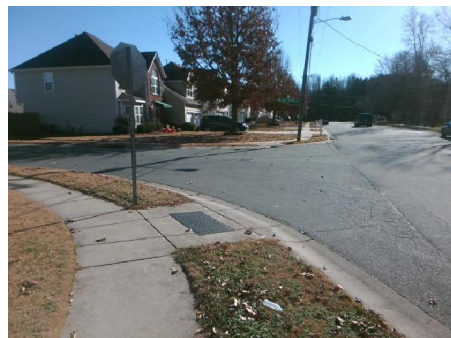
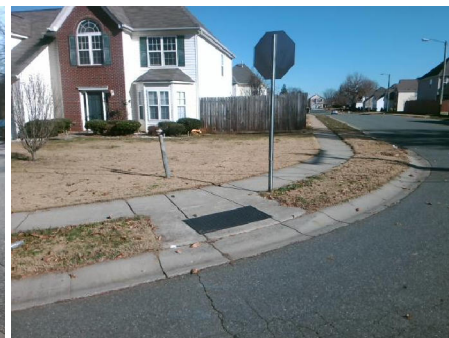
**Not Found, R304.5.1, R304.5.3**

Compliance	Description	Data	Compliance	Description	Data
N/A	Ramp Length (in)	49.5	Yes	Ramp Slope (%)	7.5
No	Ramp Width (in)	36.0	No	Ramp XSlope (%)	3.4
N/A	Flare Type LT	N/A	N/A	Flare Type RT	N/A
N/A	Flare Slope LT (%)	N/A	N/A	Flare Slope RT (%)	N/A
N/A	Flare Traversable LT?	N/A	N/A	Flare Traversable RT?	N/A
N/A	Landing Length (in)	N/A	N/A	DWS Provided?	N/A
N/A	Landing Width (in)	N/A	N/A	DWS Contrast?	N/A
N/A	Landing Slope (%)	N/A	N/A	DWS Length (in)	N/A
N/A	Landing X Slope (%)	N/A	N/A	DWS Full Width?	N/A
N/A	Landing Curb? (Y/N)	N/A	N/A	DWS Offset (in)	N/A
N/A	Shared Landing?	N/A			
N/A	Gutter Ponding?	N/A	N/A	Gutter Slope (%)	N/A
N/A	Gutter Lip Ht (in)	N/A	N/A	Gutter X Slope (%)	N/A
N/A	Painted X Walk1?	No	N/A	Painted X Walk2?	No
	X Walk 1 Direction	To W		X Walk 2 Direction	To S
N/A	X Walk 1 Width (in)	N/A	N/A	X Walk 2 Width (in)	N/A
	X Walk 1 Slope (%)	2.3		X Walk 2 Slope (%)	2.8
	X Walk 1 X Slope (%)	1.4		X Walk 2 X Slope (%)	2.8

**Remove & Replace Curb Ramp With Two New Directional Ramps or Equivalent.**
