Access Compliance Report Public Rights-of-Way (Curb Ramps)

Intersection ID: 8208 Main Street: BROOKSHIRE_BV Cross Street: N_CRIGLER_ST Location: NW

ADA ID: 70FF8A2421AC Ramp Type: Para Initial Pass/Fail: Fail Overall Compliance: No Severity Score: 13.75

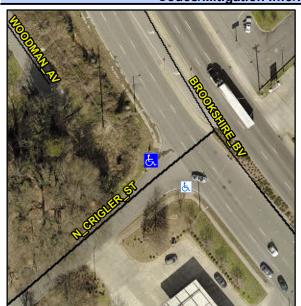
LT RP < 5%

R304.5.3, R304.3.2

Compliance Description		Data	Compliance Description		Data
N/A	Ramp Length LT (in)	62.0	N/A	Ramp Length RT (in)	59.0
Yes	Ramp Width LT (in)	72.0	Yes	Ramp Width RT (in)	72.0
Yes	Ramp Slope LT (%)	3.1	No	Ramp Slope RT (%)	9.6
No	Ramp XSlope LT (%)	3.8	Yes	Ramp XSlope RT (%)	1.2
N/A	Landing Length (in)	N/A	N/A	DWS Provided?	N/A
N/A	Landing Width (in)	N/A	N/A	DWS Contrast?	N/A
N/A	Landing Slope (%)	N/A	N/A	DWS Length (in)	N/A
N/A	Landing X Slope (%)	N/A	N/A	DWS Full Width?	N/A
N/A	Landing Curb? (Y/N)	N/A	N/A	DWS Offset (in)	N/A
N/A	Shared Landing?	N/A			
N/A	Gutter Ponding?	N/A	N/A	Gutter Slope (%)	N/A
N/A	Gutter Lip Ht (in)	N/A	N/A	Gutter X Slope (%)	N/A
N/A	Painted X Walk1?	No	N/A	Painted X Walk2?	N/A
	X Walk 1 Direction	To SE		X Walk 2 Direction	N/A
N/A	X Walk 1 Width (in)	N/A	N/A	X Walk 2 Width (in)	N/A
	X Walk 1 Slope (%)	0.8		X Walk 2 Slope (%)	N/A
	X Walk 1 X Slope (%)	1.5		X Walk 2 X Slope (%)	N/A
N/A	Ramp inside XWalk1?	N/A	N/A	Ramp inside XWalk2?	N/A

Remove & Replace Entire Ramp.
