## **Access Compliance Report Public Rights-of-Way** (Curb Ramps)

Intersection ID: 28401 Main Street: WADE ARDREY RD **Cross Street: MARVIN RD** Location: NW **Overall Compliance: No Severity Score:** ADA ID: 71217F6370BF Ramp Type: Combination1Diag Initial Pass/Fail: Fail 0

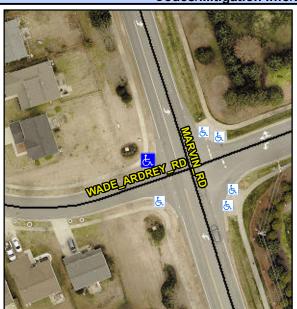
StopSign WADE ARDREY RD None MARVIN RD Possible Solutions: Remove & Replace Curb Ramp With Two New Directional Ramps or Equivalent. Surveyor Notes: N/A PROW/ADA: Not Found, R304.5.1, R304.5.3, R304.3.2
