# Access Compliance Report

## Public Rights-of-Way

### (Curb Ramps)

| Intersection ID: 52452 | Main Street: PAT_GARRETT_ST | Cross Street: BENDING_BIRCH_PL | Location: SW |

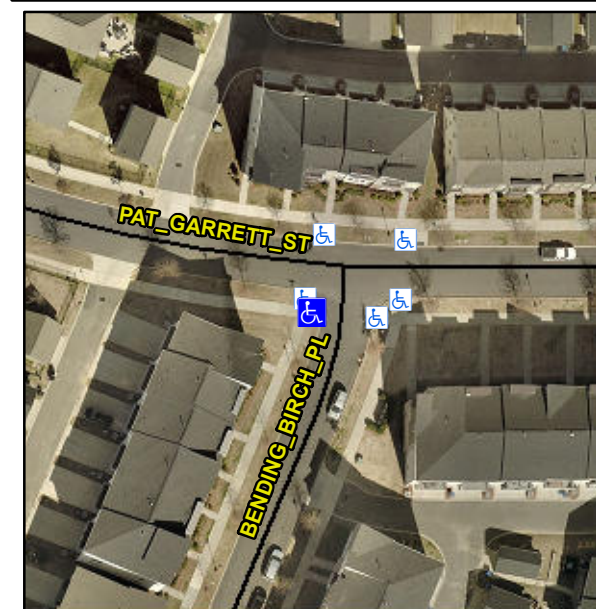
**DAMAGED GTR**

**R302.7.2**

| Compliance | Description | Data | Compliance | Description | Data |
|---|---|---|---|---|---|
| No | Gutter Lip Ht (in) | 3.0 | Yes | Gutter X Slope (%) | 2.0 |

**Grind Gutter Lip.**
