Access Compliance Report Public Rights-of-Way (Curb Ramps)

Intersection ID: 44918 Main Street: PALUSTRIS_CT Cross Street: MAPLE_PARK_LN Location: SE

ADA ID: 726D1C49C6C1 Ramp Type: PerpDiag Initial Pass/Fail: Fail Overall Compliance: No Severity Score: 43.75

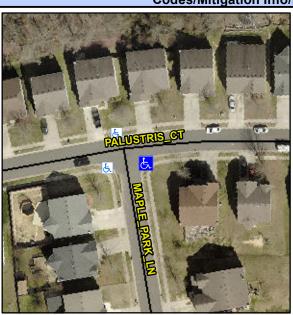
Not Found, R304.5.1, R304.2.2, R304.5.3

Compliance Description Data Compliance Description Data					
N/A	Ramp Length (in)	49.0	No	Ramp Slope (%)	20.0
No.	Ramp Width (in)	35.5	No	Ramp XSlope (%)	4.2
N/A	Flare Type LT	N/A	N/A	Flare Type RT	N/A
N/A	Flare Slope LT (%)	N/A	N/A	Flare Slope RT (%)	N/A
N/A	Flare Traversable LT?	N/A	N/A	Flare Traversable RT?	N/A
N/A	Landing Length (in)	N/A	N/A	DWS Provided?	N/A
N/A	Landing Width (in)	N/A	N/A	DWS Contrast?	N/A
N/A	Landing Slope (%)	N/A	N/A	DWS Length (in)	N/A
N/A	Landing X Slope (%)	N/A	N/A	DWS Full Width?	N/A
N/A	Landing Curb? (Y/N)	N/A	N/A	DWS Offset (in)	N/A
N/A	Shared Landing?	N/A	IN/A	DW3 Oliset (III)	N/A
N/A	Gutter Ponding?	N/A	N/A	Gutter Slope (%)	N/A
N/A	· ·	1.0			
	Gutter Lip Ht (in)	-	N/A	Gutter X Slope (%)	N/A
N/A	Painted X Walk1?	No T. N	N/A	Painted X Walk2?	No
	X Walk 1 Direction	To N		X Walk 2 Direction	To W
N/A	X Walk 1 Width (in)	N/A	N/A	X Walk 2 Width (in)	N/A
	X Walk 1 Slope (%)	3.1		X Walk 2 Slope (%)	7.7

X Walk 1 X Slope (%)	3.2		X Walk 2 X Slope (%)	1.6
N/A	Ramp inside XWalk1?	N/A	N/A	Ramp inside XWalk2?	N/A
	Road Slope (%)	5.1	N/A	Clear Space?	N/A
	Road X Slope (%)	6.5	N/A	Clear Space to XWalk (in)	N/A
N/A	Any Obstructions?	N/A	N/A	Storm Grate/Utility Hazard?	N/A
	Obstruction Type			Storm Grate/Utility Type	
		N/A			N/A
			Yes	Surface Condition? (G/P)	Good
, m

Remove & Replace Curb Ramp With Two New Directional Ramps or Equivalent.
