# Access Compliance Report

## Public Rights-of-Way

### (Curb Ramps)

| Intersection ID: 46812 | Main Street: ARBOR_VISTA_DR | Cross Street: ADLIN_AV | Location: S |

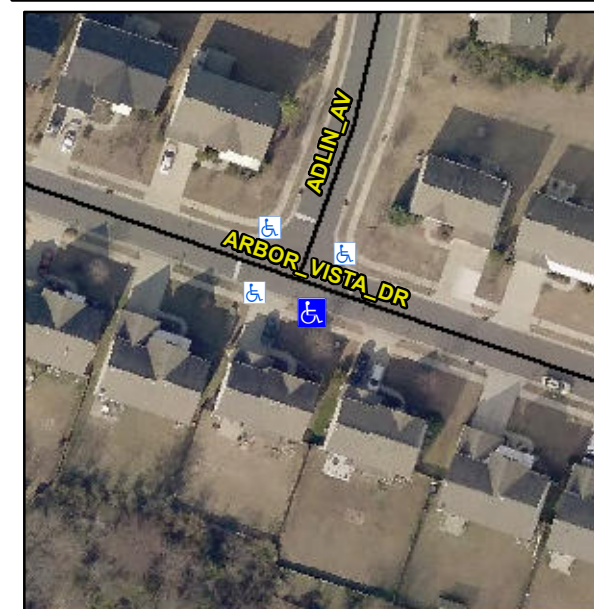
| ADA ID: 7280768C7E9B | Ramp Type: Perp | Initial Pass/Fail: Fail | Overall Compliance: No |
| Severity Score: 22.5 | | | |

**Not Found, R304.5.1, R304.2.2, R304.5.3**

| Compliance | Description | Data | Compliance | Description | Data |
|---|---|---|---|---|---|
| N/A | Ramp Length (in) | 41.0 | No | Ramp Slope (%) | 8.4 |
| No | Ramp Width (in) | 38.0 | No | Ramp XSlope (%) | 2.2 |

**Remove & Replace Entire Ramp.**

Total Cost: \$ 1850.00
