# Access Compliance Report

## Public Rights-of-Way

### (Curb Ramps)

| Intersection ID: 13736 | Main Street: CAMDEN_RD | Cross Street: N/A | Location: SE |

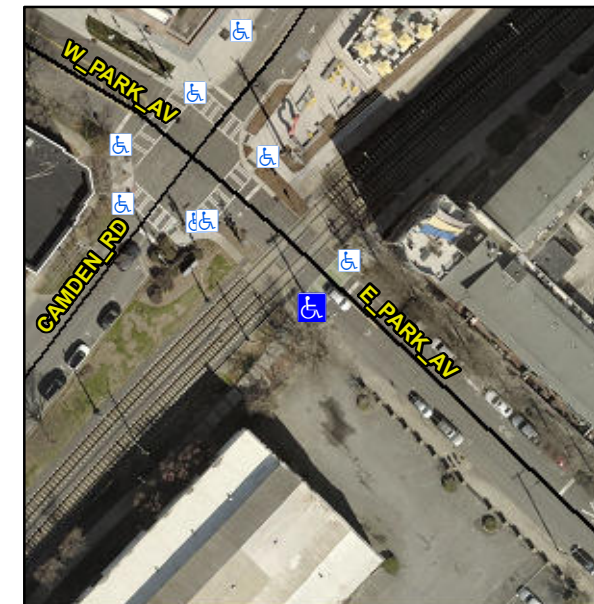
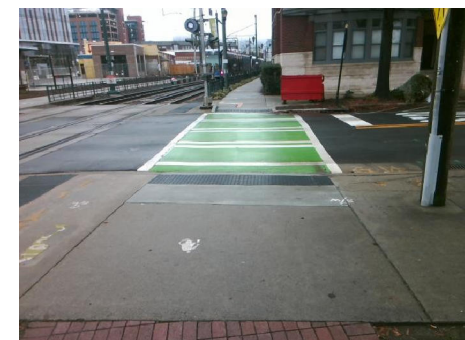
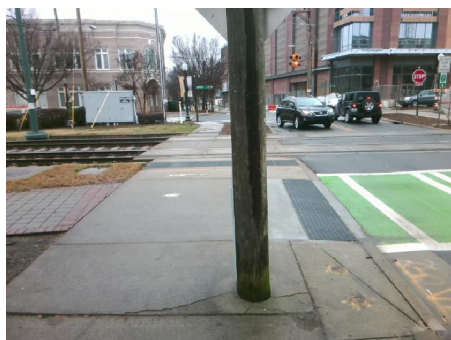
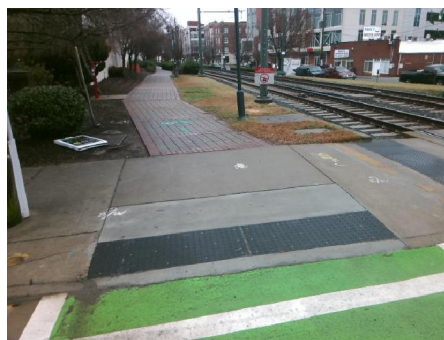
| ADA ID: 732744F42F9D | Ramp Type: BlendTrans2 | Initial Pass/Fail: Fail | Overall Compliance: No |

**Not Found, R304.5.3**

| Compliance | Description | Data | Compliance | Description | Data |
|---|---|---|---|---|---|
| Yes | Ramp Width (in) | 120.0 | No | BlendTrans XSlope (%) | 3.6 |
| | | | No | Curb Slope (%) | 6.4 |

**Remove & Replace Curb Ramp With Two New Directional Ramps or Equivalent.**
