Access Compliance Report

Public Rights-of-Way (Curb Ramps)

Intersection ID: 3879	Main Street: DAVIS_LAKE_PY	Cross Street: DEER_CROSS_TL	Location: SE
ADA ID: 735394BF9976	Ramp Type: Perp	Initial Pass/Fail: Fail	Overall Compliance: No
		Severity Score: 35

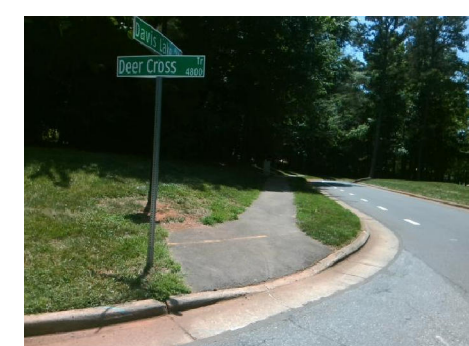
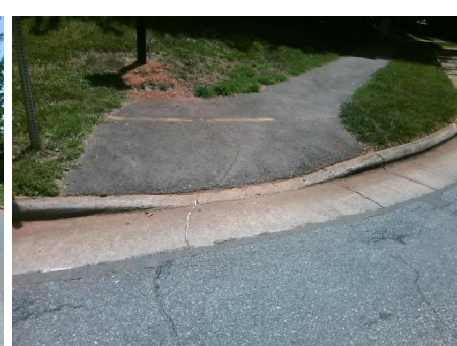
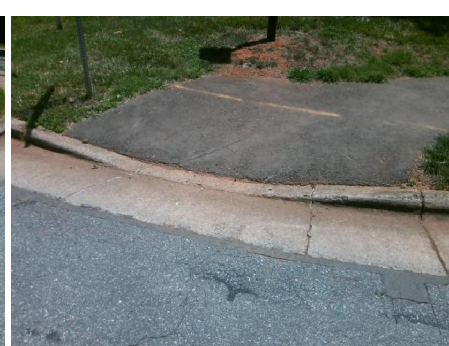
Possible Solutions:		Compliance	Description	Data	Compliance	Description	Data
	Remove & Replace Entire Ramp.		N/A	Ramp Length (in)	44.0	No	Ramp Slope (%)	24.2
			No	Ramp Width (in)	42.0	No	Ramp XSlope (%)	2.8
			N/A	Flare Type LT	N/A	N/A	Flare Type RT	N/A
			N/A	Flare Slope LT (%)	N/A	N/A	Flare Slope RT (%)	N/A
			N/A	Flare Traversable LT?	N/A	N/A	Flare Traversable RT?	N/A
			N/A	Landing Length (in)	N/A	N/A	DWS Provided?	N/A
			N/A	Landing Width (in)	N/A	N/A	DWS Contrast?	N/A
			N/A	Landing Slope (%)	N/A	N/A	DWS Length (in)	N/A
			N/A	Landing X Slope (%)	N/A	N/A	DWS Full Width?	N/A
Surveyor Notes:			N/A	Landing Curb? (Y/N)	N/A	N/A	DWS Offset (in)	N/A
N/A			N/A	Shared Landing?	N/A			
PROW/ADA:			N/A	Gutter Ponding?	N/A	N/A	Gutter Slope (%)	N/A
Not Found, R304.5.1, R304.2.2, R304.5.3			N/A	Gutter Lip Ht (in)	N/A	N/A	Gutter X Slope (%)	N/A

N/A	Painted X Walk1?	No	N/A	Painted X Walk2?	N/A
				X Walk 1 Direction	To N		X Walk 2 Direction	N/A
			N/A	X Walk 1 Width (in)	N/A	N/A	X Walk 2 Width (in)	N/A
				X Walk 1 Slope (%)	1.6		X Walk 2 Slope (%)	N/A
				X Walk 1 X Slope (%)	0.6		X Walk 2 X Slope (%)	N/A
			N/A	Ramp inside XWalk1?	N/A	N/A	Ramp inside XWalk2?	N/A
				Road Slope (%)	N/A	N/A	Clear Space?	N/A
				Road X Slope (%)	N/A	N/A	Clear Space to XWalk (in)	N/A
			N/A	Any Obstructions?	N/A	N/A	Storm Grate/Utility Hazard?	N/A
				Obstruction Type			Storm Grate/Utility Type	
						N/A		N/A
						Yes	Surface Condition? (G/P)	Good
