Access Compliance Report

Public Rights-of-Way

(Curb Ramps)

Intersection ID: 45512	Main Street: GINHOUSE_LN	Cross Street: HEDGEROW_PARK_RD	Location: SW
ADA ID: 738403D9CC69	Ramp Type: Combination1Diag	Initial Pass/Fail: Fail	Overall Compliance: No
Severity Score: 0			
Codes/Mitigation Info/Possible Solution		Field Measurements/Component Compliance

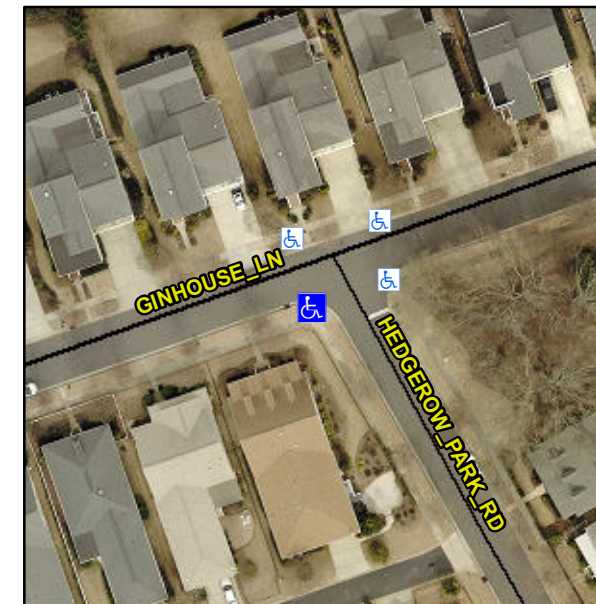
Not Found, R304.5.1, R304.5.1, R304.5.3

Remove & Replace Curb Ramp With Two New Directional Ramps or Equivalent.
