Access Compliance Report Public Rights-of-Way (Curb Ramps)

Intersection ID: 10021247 Main Street: BIRNEN_DR Cross Street: N/A Location: SW

ADA ID: 744DE622502C Ramp Type: PerpDiag Initial Pass/Fail: Fail Overall Compliance: No Severity Score: 13.75

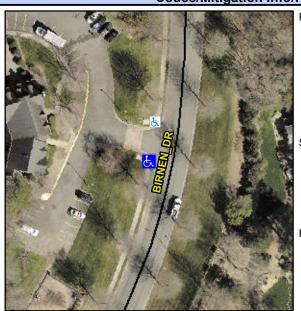
R304.2.2, R304.5.3

Field Measurements/Component Compliance					
Compliance Description		Data	Comp	oliance Description	Data
N/A	Ramp Length (in)	49.0	No	Ramp Slope (%)	11.8
Yes	Ramp Width (in)	62.0	No	Ramp XSlope (%)	4.3
N/A	Flare Type LT	N/A	N/A	Flare Type RT	N/A
N/A	Flare Slope LT (%)	N/A	N/A	Flare Slope RT (%)	N/A
N/A	Flare Traversable LT?	N/A	N/A	Flare Traversable RT?	N/A
N/A	Landing Length (in)	N/A	N/A	DWS Provided?	N/A
N/A	Landing Width (in)	N/A	N/A	DWS Contrast?	N/A
N/A	Landing Slope (%)	N/A	N/A	DWS Length (in)	N/A
N/A	Landing X Slope (%)	N/A	N/A	DWS Full Width?	N/A
N/A	Landing Curb? (Y/N)	N/A	N/A	DWS Offset (in)	N/A
N/A	Shared Landing?	N/A			
N/A	Gutter Ponding?	N/A	N/A	Gutter Slope (%)	N/A
N/A	Gutter Lip Ht (in)	N/A	N/A	Gutter X Slope (%)	N/A
N/A	Painted X Walk1?	No	N/A	Painted X Walk2?	No
	X Walk 1 Direction	To E		X Walk 2 Direction	To NE
N/A	X Walk 1 Width (in)	N/A	N/A	X Walk 2 Width (in)	N/A
	X Walk 1 Slope (%)	3.3		X Walk 2 Slope (%)	1.4

X Walk 1 X Slope (%)	1.3		X Walk 2 X Slope (%)	5.2
N/A	Ramp inside XWalk1?	N/A	N/A	Ramp inside XWalk2?	N/A
	Road Slope (%)	2.8	N/A	Clear Space?	N/A
	Road X Slope (%)	5.8	N/A	Clear Space to XWalk (in)	N/A
N/A	Any Obstructions?	N/A	N/A	Storm Grate/Utility Hazard?	N/A
	Obstruction Type			Storm Grate/Utility Type	
		N/A			N/A
			Yes	Surface Condition? (G/P)	Good
WE BOX		,	-

Remove & Replace Curb Ramp With
Two New Directional Ramps or
Equivalent.
