Access Compliance Report

Public Rights-of-Way

(Curb Ramps)

| Intersection ID: 13761 | Main Street: BAY_ST | Cross Street: PECAN_AV | Location: W |

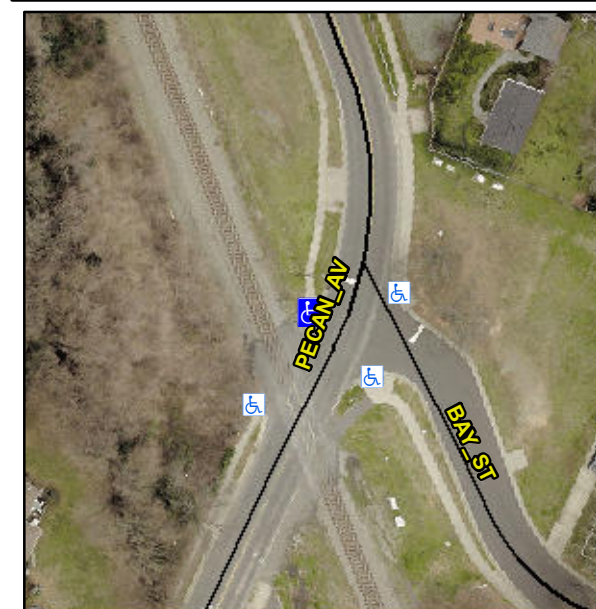
Not Found, R304.5.1, R304.2.2, R304.5.3

| Compliance | Description | Data | Compliance | Description | Data |
|---|---|---|---|---|---|
| N/A | Ramp Length (in) | 79.0 | No | Ramp Slope (%) | 9.6 |
| No | Ramp Width (in) | 44.0 | No | Ramp XSlope (%) | 3.2 |
| N/A | Gutter Ponding? | Yes | N/A | Gutter Slope (%) | N/A |

Remove & Replace Entire Ramp.
