Access Compliance Report Public Rights-of-Way (Curb Ramps)

Intersection ID: 4051Main Street:MT_ISLE_HARBOR_DRCross Street:SHADY_REACH_LNLocation:NEADA ID: 74849A5E7802Ramp Type:PerpInitial Pass/Fail:FailOverall Compliance:NoSeverity Score:10

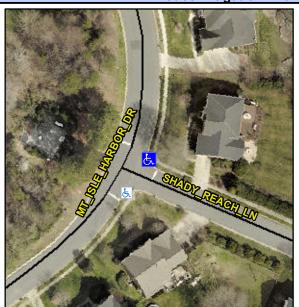
R304.5.1, R304.5.3

Field Measurements/Component Compliance					
Compliance Description		Data	Comp	liance Description	Data
N/A	Ramp Length (in)	48.0	Yes	Ramp Slope (%)	7.8
No	Ramp Width (in)	43.5	No	Ramp XSlope (%)	2.7
N/A	Flare Type LT	N/A	N/A	Flare Type RT	N/A
N/A	Flare Slope LT (%)	N/A	N/A	Flare Slope RT (%)	N/A
N/A	Flare Traversable LT?	N/A	N/A	Flare Traversable RT?	N/A
N/A	Landing Length (in)	N/A	N/A	DWS Provided?	N/A
N/A	Landing Width (in)	N/A	N/A	DWS Contrast?	N/A
N/A	Landing Slope (%)	N/A	N/A	DWS Length (in)	N/A
N/A	Landing X Slope (%)	N/A	N/A	DWS Full Width?	N/A
N/A	Landing Curb? (Y/N)	N/A	N/A	DWS Offset (in)	N/A
N/A	Shared Landing?	N/A			
N/A	Gutter Ponding?	N/A	N/A	Gutter Slope (%)	N/A
N/A	Gutter Lip Ht (in)	N/A	N/A	Gutter X Slope (%)	N/A
N/A	Painted X Walk1?	No	N/A	Painted X Walk2?	N/A
	X Walk 1 Direction	To SW		X Walk 2 Direction	N/A
N/A	X Walk 1 Width (in)	N/A	N/A	X Walk 2 Width (in)	N/A
	X Walk 1 Slope (%)	3.4		X Walk 2 Slope (%)	N/A

Remove & Replace Entire Ramp.
