Access Compliance Report

Public Rights-of-Way

(Curb Ramps)

Intersection ID: 10022444	Main Street: CANMORE_ST	Cross Street: N/A	Location: SW
ADA ID: 74A3AB77BD9B	Ramp Type: Perp	Initial Pass/Fail: Fail	Overall Compliance: No
			Severity Score: 21.25

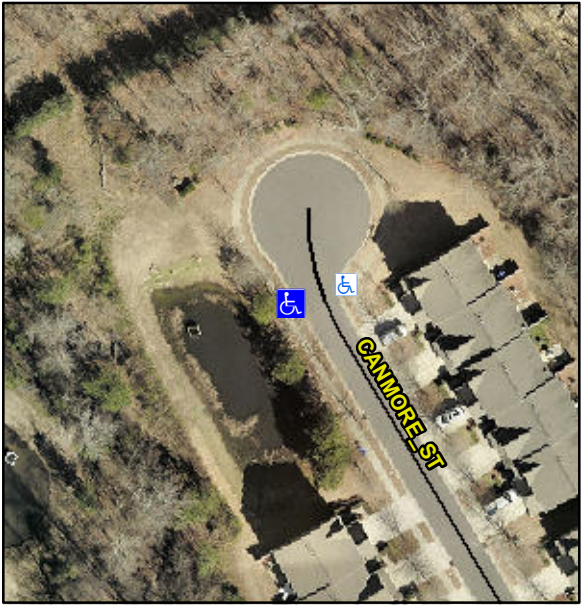
Possible Solutions:		Compliance	Description	Data
	Remove & Replace Entire Ramp.		No	Ramp Length (in)	48.0
			No	Ramp Width (in)	46.0
			N/A	Flare Type LT	N/A
			N/A	Flare Slope LT (%)	N/A
			N/A	Flare Traversable LT?	N/A
			N/A	Landing Length (in)	N/A
			N/A	Landing Width (in)	N/A
			N/A	Landing Slope (%)	N/A
			N/A	Landing X Slope (%)	N/A
<p>Surveyor Notes:</p> <p>N/A</p> <p>PROW/ADA:</p> <p>Not Found, R304.5.1, R304.2.2</p>			N/A	Flare Type RT	N/A
			N/A	Flare Slope RT (%)	N/A
			N/A	Flare Traversable RT?	N/A
			N/A	DWS Provided?	N/A
			N/A	DWS Contrast?	N/A
			N/A	DWS Length (in)	N/A
			N/A	DWS Full Width?	N/A
			N/A	DWS Offset (in)	N/A
			N/A	Shared Landing?	N/A
			N/A	Gutter Ponding?	N/A
			N/A	Gutter Lip Ht (in)	N/A
			N/A	Painted X Walk1?	No
				X Walk 1 Direction	To SE
			N/A	X Walk 1 Width (in)	N/A
				X Walk 1 Slope (%)	3.3

X Walk 1 X Slope (%)	0.9
			N/A	Ramp inside XWalk1?	N/A
			N/A	Road Slope (%)	N/A
			N/A	Road X Slope (%)	N/A
			N/A	Any Obstructions?	N/A
Total Cost:		\$ 1850.00		Obstruction Type	
			N/A		
			Yes	Surface Condition? (G/P)	Good
