# Access Compliance Report

## Public Rights-of-Way

| Intersection ID: 21797 | Main Street: GALLERIA_BV | Cross Street: MONROE_RD | Location: SE |
| ADA ID: 74C38542DCD7 | Ramp Type: Perp | Initial Pass/Fail: Fail | Overall Compliance: No |

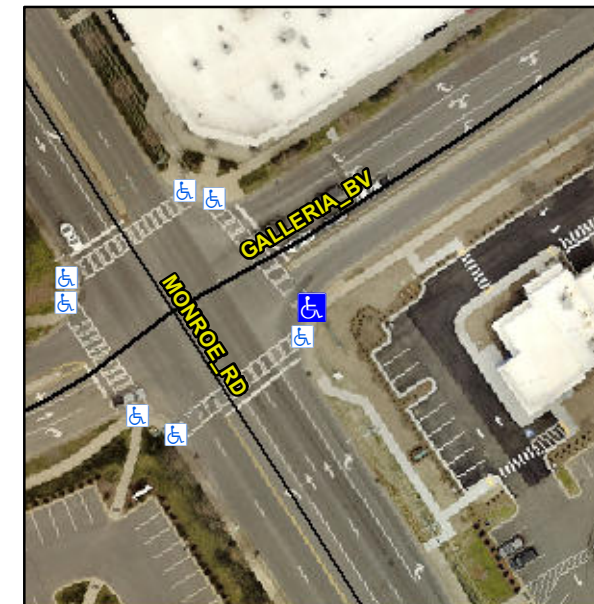
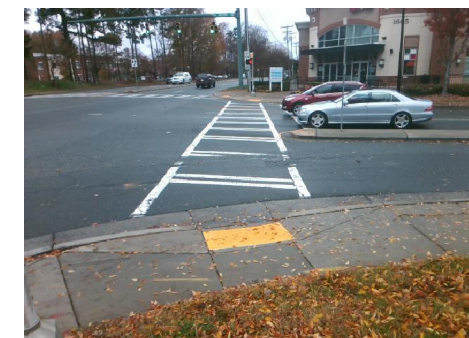
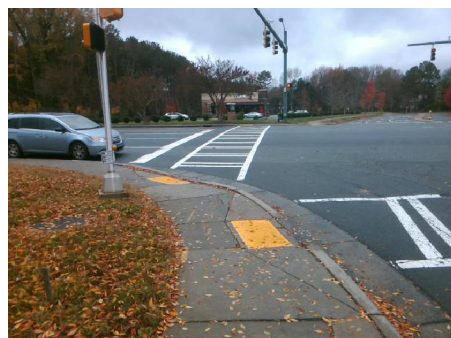
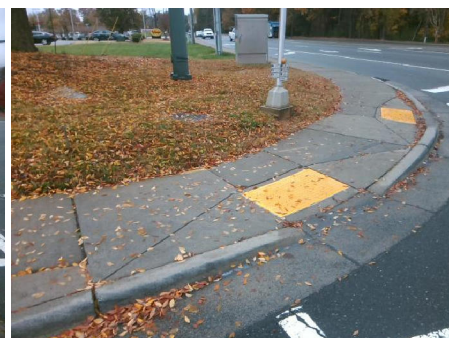
| Codes/Mitigation Info/Possible Solution | | | Severity Score: 10 |

**R304.5.1, R304.5.3**

| Compliance | Description | Data | Compliance | Description | Data |
|---|---|---|---|---|---|
| N/A | Ramp Length (in) | 37.0 | Yes | Ramp Slope (%) | 5.8 |
| No | Ramp Width (in) | 41.5 | No | Ramp XSlope (%) | 4.1 |

**Remove & Replace Entire Ramp.**
