# Access Compliance Report

## Public Rights-of-Way

### (Curb Ramps)

| Intersection ID: 46913 | Main Street: PONDEROSA_PINE_LN | Cross Street: PINYON_PINE_LN | Location: | N |

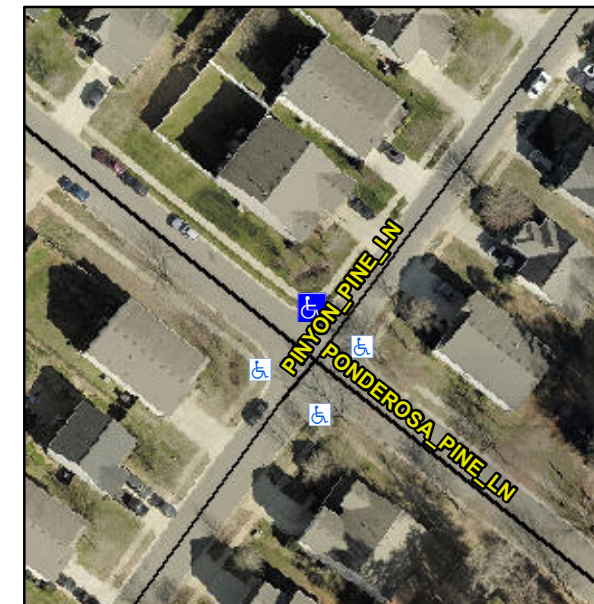
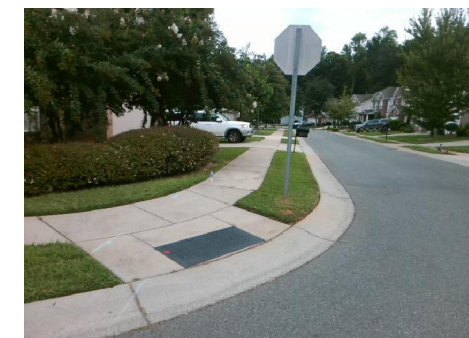
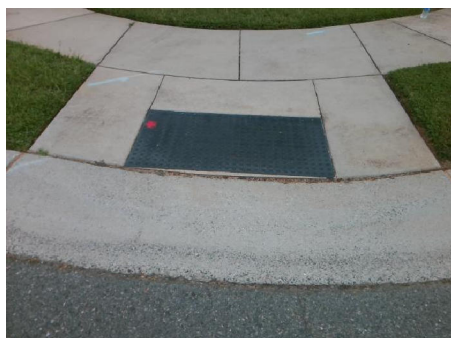
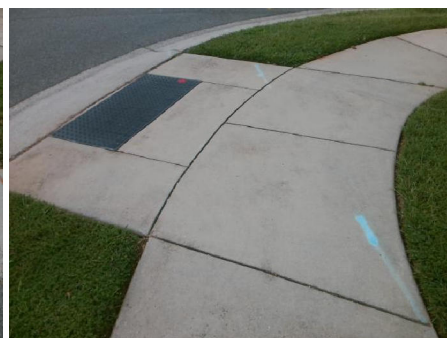
| ADA ID: 74D348013DA6 | Ramp Type: PerpDiag | Initial Pass/Fail: Pass | Overall Compliance: No | Severity Score: 5.25 |

**Not Found, R304.5.3, R304.5.4**

| Compliance | Description | Data | Compliance | Description | Data |
|---|---|---|---|---|---|
| Yes | Ramp Width (in) | 48.0 | No | Ramp XSlope (%) | 2.5 |
| No | Landing X Slope (%) | 4.1 | Yes | DWS Full Width? | Yes |
| Yes | Gutter Ponding? | No | No | Gutter Slope (%) | 5.5 |
| Yes | Gutter Lip Ht (in) | 0.0 | No | Gutter X Slope (%) | 3.2 |

**Remove & Replace Curb Ramp With Two New Directional Ramps or Equivalent. Remove & Replace Gutter.**
