# Access Compliance Report

## Public Rights-of-Way

### (Curb Ramps)

| Intersection ID: 9061 | Main Street: LUCENA_ST | Cross Street: NORRIS_AV | Location: W |

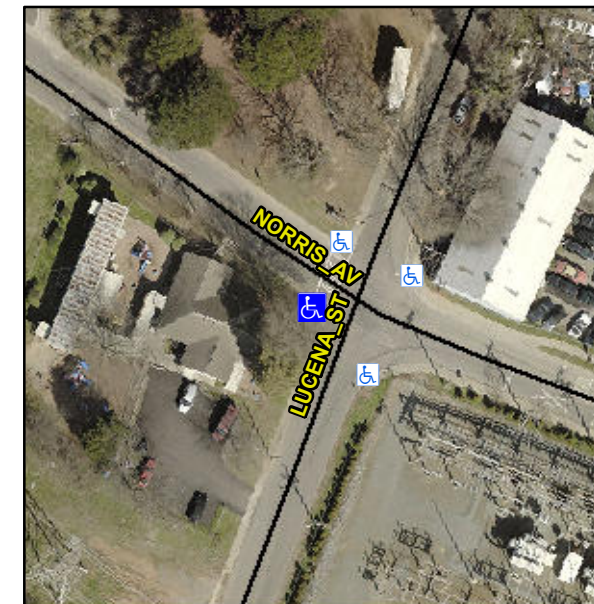
| ADA ID: 7516AE798B53 | Ramp Type: PerpDiag | Initial Pass/Fail: Fail | Overall Compliance: No |
| Severity Score: 21.25 | | | |

**Not Found, R304.5.1, R304.2.2**

| Compliance | Description | Data | Compliance | Description | Data |
|---|---|---|---|---|---|
| N/A | Ramp Length (in) | 39.0 | No | Ramp Slope (%) | 11.4 |
| No | Ramp Width (in) | 40.5 | Yes | Ramp XSlope (%) | 1.8 |

**Remove & Replace Curb Ramp With Two New Directional Ramps or Equivalent.**

Total Cost: \$ 3200.00
