Access Compliance Report

Public Rights-of-Way

(Curb Ramps)

Intersection ID: 20718	Main Street: PROVIDENCE_RD	Cross Street: EAST_BARDEN_RD	Location: S
ADA ID: 754993630169	Ramp Type: ParaDiag	Initial Pass/Fail: Fail	Overall Compliance: No
		Severity Score: 13.75

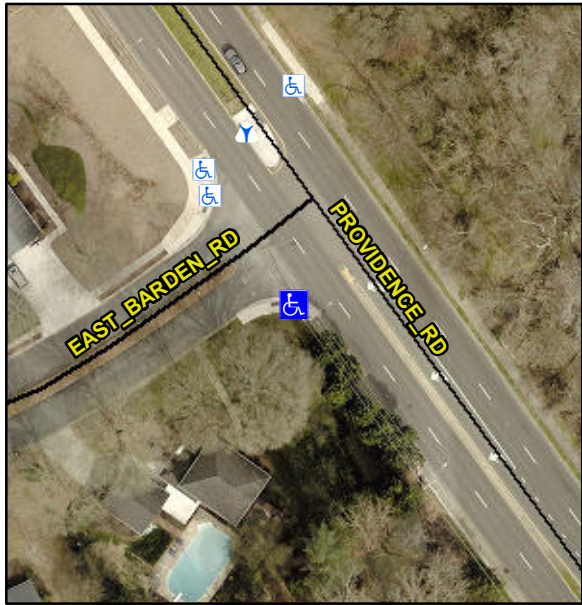
Possible Solutions:		Compliance	Description	Data
	Remove & Replace Curb Ramp With Two New Directional Ramps or Equivalent.		N/A	Ramp Length LT (in)	67.0
			Yes	Ramp Width LT (in)	59.0
			Yes	Ramp Slope LT (%)	3.4
			No	Ramp XSlope LT (%)	2.4
			N/A	Landing Length (in)	N/A
			N/A	Landing Width (in)	N/A
			N/A	Landing Slope (%)	N/A
			N/A	Landing X Slope (%)	N/A
			N/A	Landing Curb? (Y/N)	N/A
Surveyor Notes:		Compliance	Description	Data	
LT RP < 5%		N/A	Ramp Length RT (in)	60.0	
		Yes	Ramp Width RT (in)	60.0	
		No	Ramp Slope RT (%)	9.5	
		Yes	Ramp XSlope RT (%)	1.3	
		N/A	DWS Provided?	N/A	
		N/A	DWS Contrast?	N/A	
		N/A	DWS Length (in)	N/A	
		N/A	DWS Full Width?	N/A	
		N/A	DWS Offset (in)	N/A	
PROW/ADA:		N/A	Gutter Slope (%)	N/A	
R304.5.3, R304.3.2		N/A	Gutter X Slope (%)	N/A	
		N/A	Painted X Walk2?	No	
			X Walk 2 Direction	To NW

N/A	X Walk 2 Width (in)	N/A	
			X Walk 2 Slope (%)	6.2	
			X Walk 2 X Slope (%)	3.8	
		N/A	Ramp inside XWalk2?	N/A	
		N/A	Clear Space?	N/A	
		N/A	Clear Space to XWalk (in)	N/A	
		N/A	Storm Grate/Utility Hazard?	N/A	
			Storm Grate/Utility Type		
Total Cost:		N/A		N/A	
		Yes	Surface Condition? (G/P)	Good	
		N/A	Curb Slope (%)	5.3
