# Access Compliance Report

## Public Rights-of-Way

### (Curb Ramps)

Intersection ID: 9767	Main Street: ROZZELLES_FERRY_RD	Cross Street: ZEBULON_AV	Location: SE
ADA ID: 766905730C11	Ramp Type: Perp	Initial Pass/Fail: Fail	Overall Compliance: No
			Severity Score: 26.25

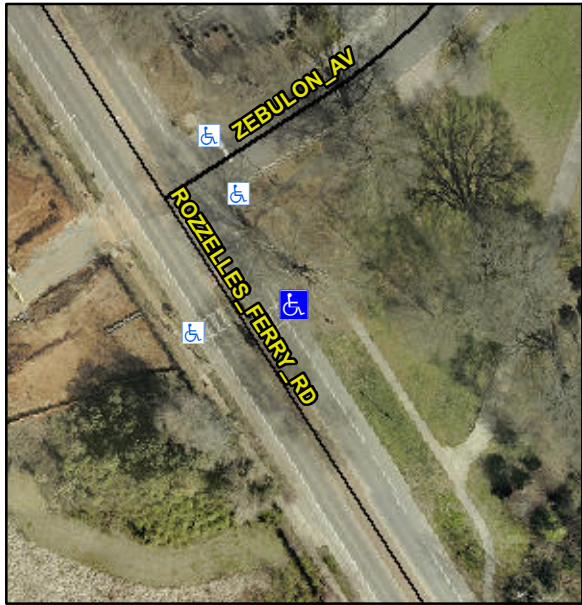
Possible Solutions:		Compliance			Description			Data	Compliance			Description			Data				
	Remove & Replace Entire Ramp.		N/A	Ramp Length (in)			56.0			No	Ramp Slope (%)			15.5						
			Yes	Ramp Width (in)			58.0			Yes	Ramp XSlope (%)			2.3						
			N/A	Flare Type LT			N/A			N/A	Flare Type RT			N/A						
			N/A	Flare Slope LT (%)			N/A			N/A	Flare Slope RT (%)			N/A						
			N/A	Flare Traversable LT?			N/A			N/A	Flare Traversable RT?			N/A						
			N/A	Landing Length (in)			N/A			N/A	DWS Provided?			N/A						
			N/A	Landing Width (in)			N/A			N/A	DWS Contrast?			N/A						
			N/A	Landing Slope (%)			N/A			N/A	DWS Length (in)			N/A						
			N/A	Landing X Slope (%)			N/A			N/A	DWS Full Width?			N/A						
Surveyor Notes:		N/A	Landing Curb? (Y/N)			N/A			N/A	DWS Offset (in)			N/A							
PROW/ADA:		Not Found, R304.2.2	Shared Landing?			N/A

Gutter Ponding?			N/A			N/A	Gutter Slope (%)			N/A							
			Gutter Lip Ht (in)			1.0			N/A	Gutter X Slope (%)			N/A							
			Painted X Walk1?			Yes			N/A	Painted X Walk2?			N/A							
			X Walk 1 Direction			To NW			X Walk 2 Direction						N/A					
			X Walk 1 Width (in)			109.0			N/A	X Walk 2 Width (in)			N/A							
			X Walk 1 Slope (%)			3.7			X Walk 2 Slope (%)						N/A					
			X Walk 1 X Slope (%)			4.0			X Walk 2 X Slope (%)						N/A					
			Ramp inside XWalk1?			Yes			N/A	Ramp inside XWalk2?			N/A							
			Road Slope (%)			N/A			N/A	Clear Space?			N/A							
			Road X Slope (%)			N/A			N/A	Clear Space to XWalk (in)			N/A							
			Any Obstructions?			N/A			N/A	Storm Grate/Utility Hazard?			N/A							
			Obstruction Type						Storm Grate/Utility Type											
									N/A						N/A					
									Yes						Surface Condition? (G/P)			Good		
Total Cost:		\$ 1850.00
