# Access Compliance Report

## Public Rights-of-Way

### (Curb Ramps)

| Intersection ID: 3072 | Main Street: PANTHERSVILLE_DR | Cross Street: PROSPERITY_CHURCH_RD | Location: S |

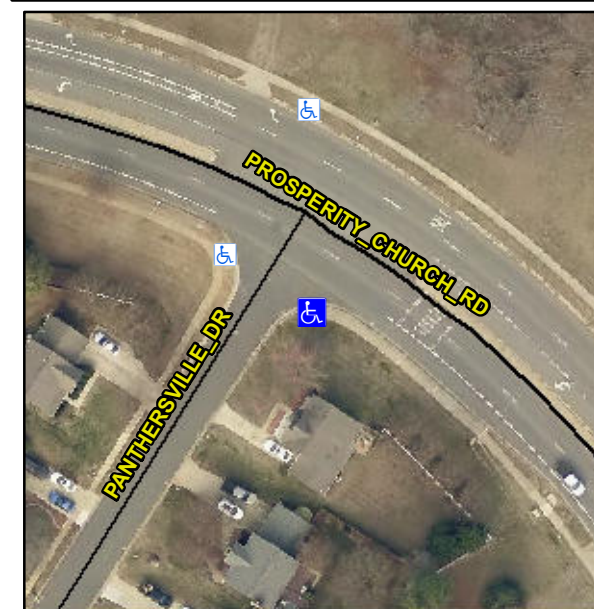
| ADA ID: 766AB24BC15E | Ramp Type: Perp | Initial Pass/Fail: Fail | Overall Compliance: No |

| Severity Score: 33.75 | | | |

**R304.5.1, R304.2.2**

| Compliance | Description | Data | Compliance | Description | Data |
|---|---|---|---|---|---|
| N/A | Ramp Length (in) | 24.0 | No | Ramp Slope (%) | 20.0 |
| No | Ramp Width (in) | 46.0 | Yes | Ramp XSlope (%) | 0.1 |

**Remove & Replace Entire Ramp.**

Total Cost: \$ 1850.00
