Access Compliance Report Public Rights-of-Way (Curb Ramps)

Intersection ID: 24119Main Street:LIVINGSTON_MILL_RDCross Street:LONGHEDGE_LNLocation:NEADA ID: 76A599D83F32Ramp Type:PerpDiagInitial Pass/Fail:FailOverall Compliance:NoSeverity Score:25

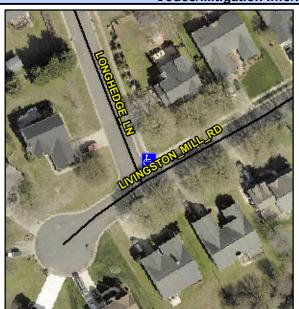
R304.2.2, R304.5.3

Field Measurements/Component Compliance					
Compliance Description		Data	Comp	liance Description	Data
N/A	Ramp Length (in)	93.0	No	Ramp Slope (%)	10.9
Yes	Ramp Width (in)	48.0	No	Ramp XSlope (%)	5.5
N/A	Flare Type LT	N/A	N/A	Flare Type RT	N/A
N/A	Flare Slope LT (%)	N/A	N/A	Flare Slope RT (%)	N/A
N/A	Flare Traversable LT?	N/A	N/A	Flare Traversable RT?	N/A
N/A	Landing Length (in)	N/A	N/A	DWS Provided?	N/A
N/A	Landing Width (in)	N/A	N/A	DWS Contrast?	N/A
N/A	Landing Slope (%)	N/A	N/A	DWS Length (in)	N/A
N/A	Landing X Slope (%)	N/A	N/A	DWS Full Width?	N/A
N/A	Landing Curb? (Y/N)	N/A	N/A	DWS Offset (in)	N/A
N/A	Shared Landing?	N/A			
N/A	Gutter Ponding?	N/A	N/A	Gutter Slope (%)	N/A
N/A	Gutter Lip Ht (in)	N/A	N/A	Gutter X Slope (%)	N/A
N/A	Painted X Walk1?	No	N/A	Painted X Walk2?	No
	X Walk 1 Direction	To SW		X Walk 2 Direction	To S
N/A	X Walk 1 Width (in)	N/A	N/A	X Walk 2 Width (in)	N/A
	X Walk 1 Slope (%)	4.2		X Walk 2 Slope (%)	3.8

X Walk 1 X Slope (%)	4.6		X Walk 2 X Slope (%)	4.4
N/A	Ramp inside XWalk1?	N/A	N/A	Ramp inside XWalk2?	N/A
	Road Slope (%)	5.0	N/A	Clear Space?	N/A
	Road X Slope (%)	1.9	N/A	Clear Space to XWalk (in)	N/A
N/A	Any Obstructions?	N/A	N/A	Storm Grate/Utility Hazard?	N/A
	Obstruction Type			Storm Grate/Utility Type	
		N/A			N/A
			Yes	Surface Condition? (G/P)	Good
NAT WELL	All since

Remove & Replace Curb Ramp With
Two New Directional Ramps or
Equivalent.
