Access Compliance Report

Public Rights-of-Way

(Curb Ramps)

| Intersection ID: 4419 | Main Street: DELROSE_LN | Cross Street: LARKHULL_DR | Location: SW |

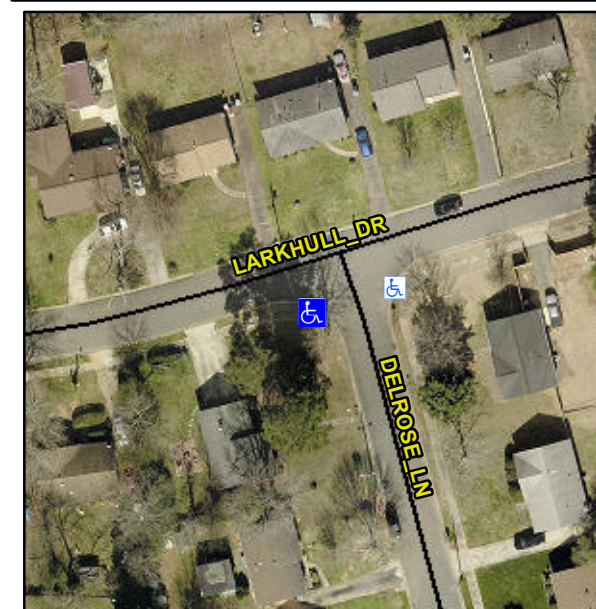
Not Found, R304.5.3, R304.2.2-Perp, R304.3.2-Para, R305, R302.7.2

| Compliance | Description | Data | Compliance | Description | Data |
|---|---|---|---|---|---|
| Yes | Ramp Width (in) | 135.0 | No | BlendTrans XSlope (%) | 3.3 |
| Yes | Landing Length (in) | 54.0 | No | DWS Provided? | No |
| No | Landing Slope (%) | 6.1 | N/A | DWS Length (in) | N/A |
| No | Gutter Lip Ht (in) | 1.0 | No | Gutter X Slope (%) | 3.9 |

Remove & Replace Curb Ramp With Two New Directional Ramps or Equivalent. Remove & Replace Gutter.
