Access Compliance Report

Public Rights-of-Way

(Curb Ramps)

| Intersection ID: 5049 | Main Street: ALEXANDER_GLEN_DR | Cross Street: MARY_CHARLOTTE_DR | Location: SE |

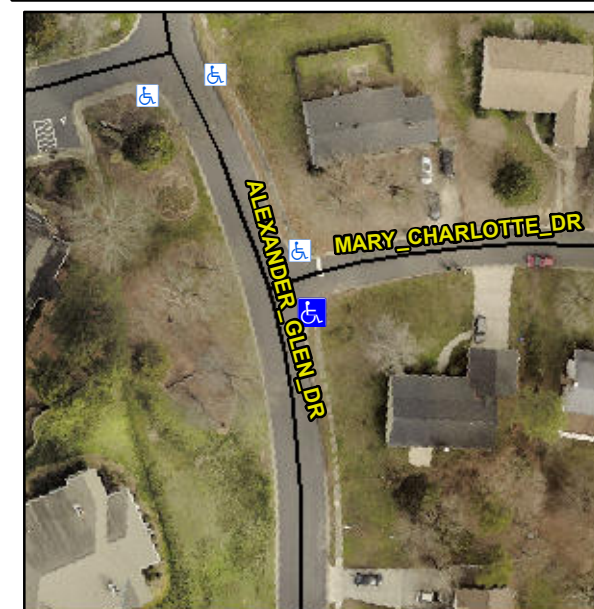
| ADA ID: 76DB9679A5B4 | Ramp Type: Perp | Initial Pass/Fail: Fail | Overall Compliance: No |
| Severity Score: 21.25 | | | |

Not Found, R304.5.1, R304.2.2

| Compliance | Description | Data | Compliance | Description | Data |
|---|---|---|---|---|---|
| N/A | Ramp Length (in) | 54.0 | No | Ramp Slope (%) | 8.4 |
| No | Ramp Width (in) | 43.0 | Yes | Ramp XSlope (%) | 0.2 |

Remove & Replace Entire Ramp.
