Access Compliance Report Public Rights-of-Way (Curb Ramps)

Intersection ID: 26030 Main Street: BAYBROOK_LN Cross Street: REAFIELD DR Location: N

ADA ID: 7750851FDBA4 Ramp Type: PerpDiag Initial Pass/Fail: Fail Overall Compliance: No Severity Score: 46.25

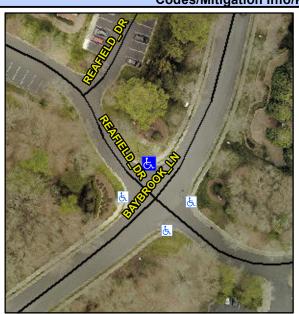
Not Found, R304.5.1, R304.2.2, R304.5.3

Compliance Description Data Compliance Description Data No N/A Ramp Length (in) 72.0 Ramp Slope (%) 8.6 No No Ramp Width (in) 43.0 Ramp XSlope (%) 7.7 N/A N/A Flare Type LT N/A Flare Type RT N/A N/A N/A N/A Flare Slope RT (%) N/A Flare Slope LT (%) N/A Flare Traversable LT? N/A N/A Flare Traversable RT? N/A N/A N/A N/A DWS Provided? N/A Landing Length (in) N/A Landing Width (in) N/A N/A **DWS Contrast?** N/A N/A N/A N/A Landing Slope (%) DWS Length (in) N/A N/A Landing X Slope (%) N/A N/A DWS Full Width? N/A N/A Landing Curb? (Y/N) N/A N/A DWS Offset (in) N/A N/A N/A Shared Landing? N/A **Gutter Ponding?** N/A N/A Gutter Slope (%) N/A N/A Gutter Lip Ht (in) N/A N/A Gutter X Slope (%) N/A N/A Painted X Walk1? No N/A Painted X Walk2? No X Walk 1 Direction To SW X Walk 2 Direction To SE N/A N/A X Walk 1 Width (in) X Walk 2 Width (in) N/A X Walk 1 Slope (%) 2.0 X Walk 2 Slope (%) 3.8 X Walk 2 X Slope (%) X Walk 1 X Slope (%) 4.5 3.4 N/A N/A N/A Ramp inside XWalk2? N/A Ramp inside XWalk1? Road Slope (%) 2.9 N/A Clear Space? N/A N/A Road X Slope (%) 0.2 Clear Space to XWalk (in) N/A N/A N/A N/A Any Obstructions? Storm Grate/Utility Hazard? N/A

Remove & Replace Curb Ramp With Two New Directional Ramps or Equivalent.
