Access Compliance Report Public Rights-of-Way (Curb Ramps)

Intersection ID: 46237Main Street:LINDEN_RIDGE_LNCross Street:MCINTYRE_AVLocation:NEADA ID: 77780B411B18Ramp Type:PerpDiagInitial Pass/Fail:FailOverall Compliance:NoSeverity Score:21.25

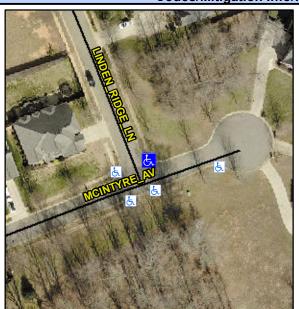
Field Measure	ments/C	ompoi	nent Compliance	
Compliance Description		Data	Compliance Description		Data
N/A	Ramp Length (in)	46.5	Yes	Ramp Slope (%)	5.0
No	Ramp Width (in)	37.0	No	Ramp XSlope (%)	5.1
N/A	Flare Type LT	N/A	N/A	Flare Type RT	N/A
N/A	Flare Slope LT (%)	N/A	N/A	Flare Slope RT (%)	N/A
N/A	Flare Traversable LT?	N/A	N/A	Flare Traversable RT?	N/A
N/A	Landing Length (in)	N/A	N/A	DWS Provided?	N/A
N/A	Landing Width (in)	N/A	N/A	DWS Contrast?	N/A
N/A	Landing Slope (%)	N/A	N/A	DWS Length (in)	N/A
N/A	Landing X Slope (%)	N/A	N/A	DWS Full Width?	N/A
N/A	Landing Curb? (Y/N)	N/A	N/A	DWS Offset (in)	N/A
N/A	Shared Landing?	N/A			
N/A	Gutter Ponding?	N/A	N/A	Gutter Slope (%)	N/A
N/A	Gutter Lip Ht (in)	2.0	N/A	Gutter X Slope (%)	N/A
N/A	Painted X Walk1?	No	N/A	Painted X Walk2?	No
	X Walk 1 Direction	To W		X Walk 2 Direction	To S
N/A	X Walk 1 Width (in)	N/A	N/A	X Walk 2 Width (in)	N/A
	X Walk 1 Slope (%)	0.5		X Walk 2 Slope (%)	2.6

X Walk 1 X Slope (%)	2.3		X Walk 2 X Slope (%)	3.2
N/A	Ramp inside XWalk1?	N/A	N/A	Ramp inside XWalk2?	N/A
	Road Slope (%)	0.6	N/A	Clear Space?	N/A
	Road X Slope (%)	0.2	N/A	Clear Space to XWalk (in)	N/A
N/A	Any Obstructions?	N/A	N/A	Storm Grate/Utility Hazard?	N/A
	Obstruction Type			Storm Grate/Utility Type	
		N/A			N/A
			Yes	Surface Condition? (G/P)	Good

Possible Solution							
Possible Solutions:							
Remove & Replace Curb Ramp With Two New Directional Ramps or Equivalent.							
Surveyor Notes: N/A							
PROW/ADA: Not Found, R304.5.1, R304.5.3
