# Access Compliance Report

## Public Rights-of-Way

| Intersection ID: 31368 | Main Street: GREENWAY_VISTA_LN | Cross Street: LINDA_VISTA_LN | Location: | S |
| ADA ID: 779AFF1F9F02 | Ramp Type: BlendTrans1 | Initial Pass/Fail: Fail | Overall Compliance: No | Severity Score: 25 |

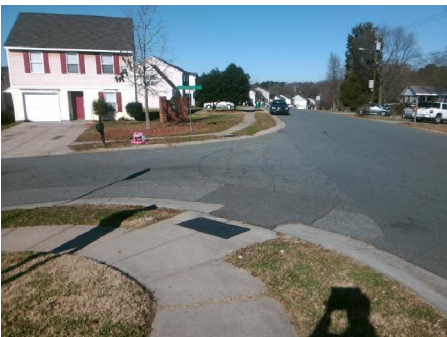
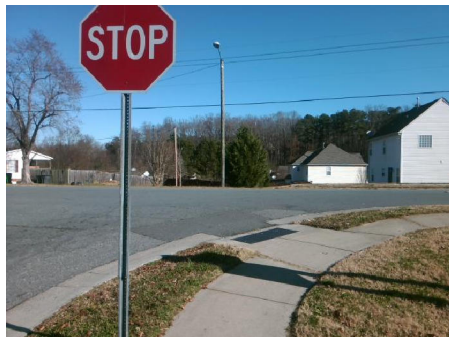
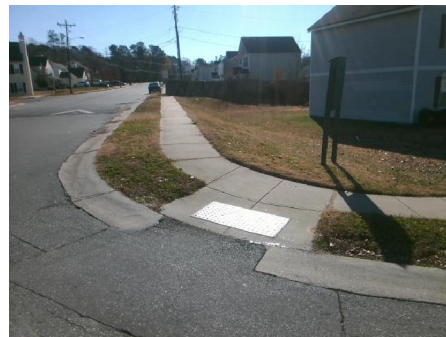
**R304.5.3**

| Compliance | Description | Data | Compliance | Description | Data |
|---|---|---|---|---|---|
| Yes | Ramp Width (in) | 48.0 | No | BlendTrans XSlope (%) | 7.9 |

**Remove & Replace Curb Ramp With Two New Directional Ramps or Equivalent.**
