Access Compliance Report Public Rights-of-Way (Curb Ramps)

Intersection ID: 45241 Main Street: TALUS_TRACE_LN Cross Street: TALUS_TRACE_LN Location: N

ADA ID: 77FF2D38635B Ramp Type: Perp Initial Pass/Fail: Fail Overall Compliance: No Severity Score: 13.75

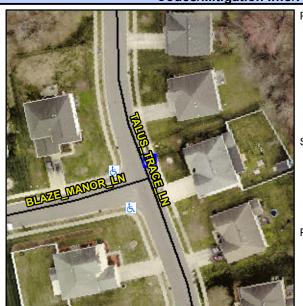
Field Measurements/Component Compliance						
Compliance Description Data		Comp	liance Description	Data		
N/A	Ramp Length (in)	46.5	No	Ramp Slope (%)	11.9	
Yes	Ramp Width (in)	48.0	No	Ramp XSlope (%)	2.7	
N/A	Flare Type LT	N/A	N/A	Flare Type RT	N/A	
N/A	Flare Slope LT (%)	N/A	N/A	Flare Slope RT (%)	N/A	
N/A	Flare Traversable LT?	N/A	N/A	Flare Traversable RT?	N/A	
N/A	Landing Length (in)	N/A	N/A	DWS Provided?	N/A	
N/A	Landing Width (in)	N/A	N/A	DWS Contrast?	N/A	
N/A	Landing Slope (%)	N/A	N/A	DWS Length (in)	N/A	
N/A	Landing X Slope (%)	N/A	N/A	DWS Full Width?	N/A	
N/A	Landing Curb? (Y/N)	N/A	N/A	DWS Offset (in)	N/A	
N/A	Shared Landing?	N/A				
N/A	Gutter Ponding?	N/A	N/A	Gutter Slope (%)	N/A	
N/A	Gutter Lip Ht (in)	N/A	N/A	Gutter X Slope (%)	N/A	
N/A	Painted X Walk1?	No	N/A	Painted X Walk2?	N/A	
	X Walk 1 Direction	To W		X Walk 2 Direction	N/A	
N/A	X Walk 1 Width (in)	N/A	N/A	X Walk 2 Width (in)	N/A	
	X Walk 1 Slope (%)	1.7		X Walk 2 Slope (%)	N/A

X Walk 1 X Slope (%)	2.2		X Walk 2 X Slope (%)	N/A	
N/A	Ramp inside XWalk1?	N/A	N/A	Ramp inside XWalk2?	N/A	
	Road Slope (%)	N/A	N/A	Clear Space?	N/A	
	Road X Slope (%)	N/A	N/A	Clear Space to XWalk (in)	N/A	
N/A	Any Obstructions?	N/A	N/A	Storm Grate/Utility Hazard?	N/A	
	Obstruction Type			Storm Grate/Utility Type		
		N/A			N/A	
			Yes	Surface Condition? (G/P)	Good

Possible Solutions:	9
Remove & Replace Entire Ramp.	ı
	`
	N
	ı
Cumusuum Nataas	
Surveyor Notes:	
N/A	
PROW/ADA:	,
Not Found, R304.2.2, R304.5.3	r
	ı
	ı
	_
	ı
