Access Compliance Report

Public Rights-of-Way

(Curb Ramps)

Intersection ID: 28913	Main Street: ELIZABETH COLLINS BV	Cross Street: SPRINGBANK LN	Location: SW
ADA ID: 7820A95C4475	Ramp Type: PerpDiag	Initial Pass/Fail: Fail	Overall Compliance: No
Severity Score: 12.5			
Codes/Mitigation Info/Possible Solution		Field Measurements/Component Compliance

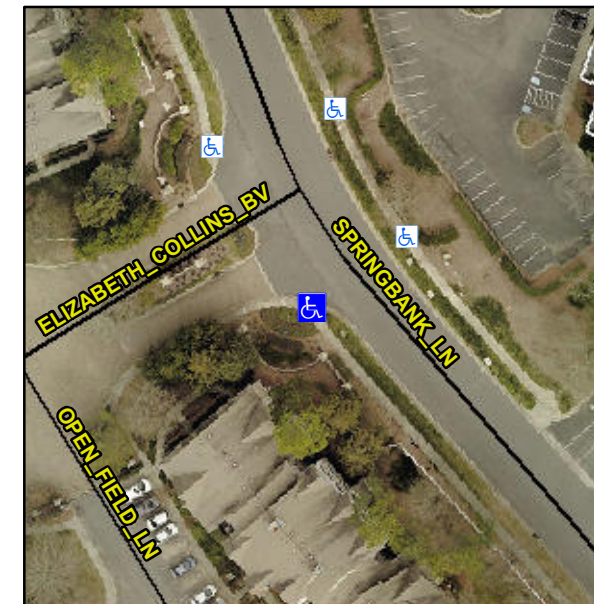
Not Found, R304.2.2

Compliance	Description	Data	Compliance	Description	Data
N/A	Ramp Length (in)	75.0	No	Ramp Slope (%)	9.8
Yes	Ramp Width (in)	52.0	Yes	Ramp XSlope (%)	1.3
N/A	Flare Type LT	N/A	N/A	Flare Type RT	N/A
N/A	Flare Slope LT (%)	N/A	N/A	Flare Slope RT (%)	N/A
N/A	Flare Traversable LT?	N/A	N/A	Flare Traversable RT?	N/A
N/A	Landing Length (in)	N/A	N/A	DWS Provided?	N/A
N/A	Landing Width (in)	N/A	N/A	DWS Contrast?	N/A
N/A	Landing Slope (%)	N/A	N/A	DWS Length (in)	N/A
N/A	Landing X Slope (%)	N/A	N/A	DWS Full Width?	N/A
N/A	Landing Curb? (Y/N)	N/A	N/A	DWS Offset (in)	N/A
N/A	Shared Landing?	N/A			
N/A	Gutter Ponding?	N/A	N/A	Gutter Slope (%)	N/A
N/A	Gutter Lip Ht (in)	N/A	N/A	Gutter X Slope (%)	N/A
N/A	Painted X Walk1?	No	N/A	Painted X Walk2?	No
	X Walk 1 Direction	To NE		X Walk 2 Direction	To NW
N/A	X Walk 1 Width (in)	N/A	N/A	X Walk 2 Width (in)	N/A
	X Walk 1 Slope (%)	5.9		X Walk 2 Slope (%)	3.9
	X Walk 1 X Slope (%)	1.5		X Walk 2 X Slope (%)	5.3

N/A	Ramp inside XWalk1?	N/A	N/A	Ramp inside XWalk2?	N/A
	Road Slope (%)	0.0	N/A	Clear Space?	N/A
	Road X Slope (%)	6.7	N/A	Clear Space to XWalk (in)	N/A
N/A	Any Obstructions?	N/A	N/A	Storm Grate/Utility Hazard?	N/A
	Obstruction Type			Storm Grate/Utility Type	
		N/A			N/A
			Yes	Surface Condition? (G/P)	Good

Remove & Replace Curb Ramp With Two New Directional Ramps or Equivalent.
