Access Compliance Report

Public Rights-of-Way

(Curb Ramps)

Intersection ID: 49791	Main Street: BAHIA_LN	Cross Street: BARLEY_LN	Location: E
ADA ID: 789664D1D576	Ramp Type: Perp	Initial Pass/Fail: Pass	Overall Compliance: No
Codes/Mitigation Info/Possible Solution		Field Measurements/Component Compliance	
Severity Score: 20.25

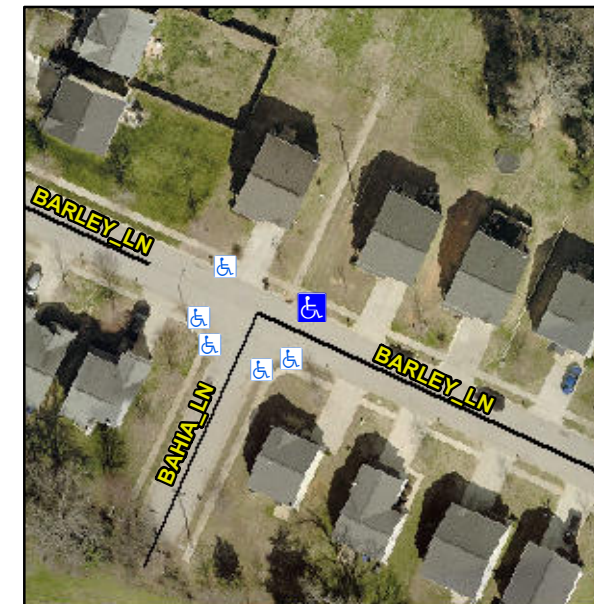
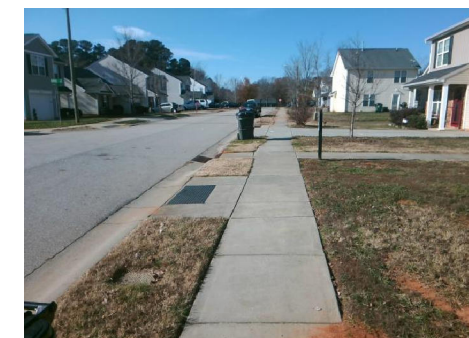
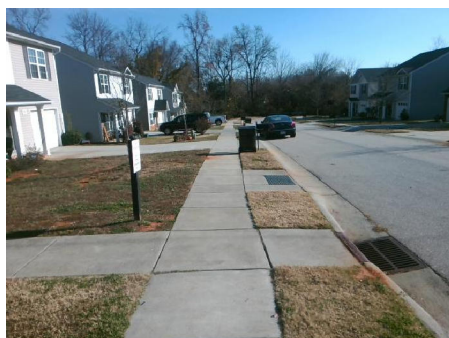
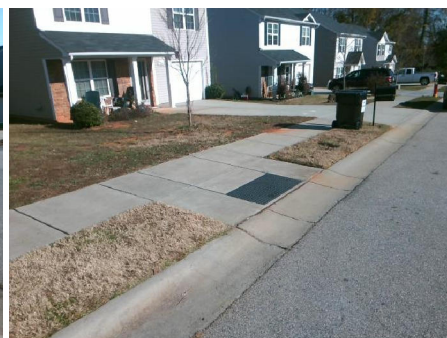
**Not Found, R304.5.3, R304.2.1,
R304.2.2-Perp, R304.3.2-Para,
R302.7.2, R304.5.4**

Compliance	Description	Data	Compliance	Description	Data
N/A	Ramp Length (in)	48.0	Yes	Ramp Slope (%)	5.7
Yes	Ramp Width (in)	48.0	No	Ramp XSlope (%)	3.7
N/A	Flare Type LT	Sloped	N/A	Flare Type RT	N/A
N/A	Flare Slope LT (%)	5.8	Yes	Flare Slope RT (%)	2.4
N/A	Flare Traversable LT?	Yes	N/A	Flare Traversable RT?	Yes
No	Landing Length (in)	46.0	Yes	DWS Provided?	Yes
Yes	Landing Width (in)	48.0	Yes	DWS Contrast?	Yes
No	Landing Slope (%)	4.4	Yes	DWS Length (in)	24.5
No	Landing X Slope (%)	3.7	Yes	DWS Full Width?	Yes
N/A	Landing Curb? (Y/N)	No	Yes	DWS Offset (in)	1.5
N/A	Shared Landing?	No			
Yes	Gutter Ponding?	No	No	Gutter Slope (%)	6.4
No	Gutter Lip Ht (in)	1.5	No	Gutter X Slope (%)	4.1
N/A	Painted X Walk1?	No	N/A	Painted X Walk2?	N/A
	X Walk 1 Direction	To SW		X Walk 2 Direction	N/A
N/A	X Walk 1 Width (in)	N/A	N/A	X Walk 2 Width (in)	N/A
	X Walk 1 Slope (%)	1.8		X Walk 2 Slope (%)	N/A
	X Walk 1 X Slope (%)	3.5		X Walk 2 X Slope (%)	N/A

N/A	Ramp inside XWalk1?	N/A	N/A	Ramp inside XWalk2?	N/A
	Road Slope (%)	N/A	N/A	Clear Space?	Yes
	Road X Slope (%)	N/A	N/A	Clear Space to XWalk (in)	N/A
Yes	Any Obstructions?	No	Yes	Storm Grate/Utility Hazard?	No
	Obstruction Type			Storm Grate/Utility Type	
		N/A			N/A
			Yes	Surface Condition? (G/P)	Good

**Remove & Replace Entire Ramp.
Remove & Replace Gutter.**
