Access Compliance Report Public Rights-of-Way (Curb Ramps)

Intersection ID: 18263 Main Street: DRIFTER_DR **Cross Street: JALDENA_DR** Location: SE **Overall Compliance: No Severity Score:** ADA ID: 789C82C73E47 Ramp Type: Perp Initial Pass/Fail: Fail 25

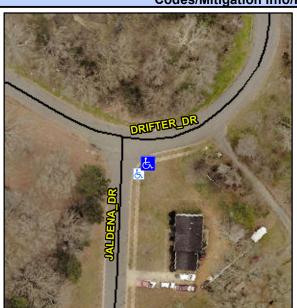
· cccibic cciation	
Possible Solutions:	Co
Remove & Replace Entire Ramp.	N/A
·	Ye
	N/A
	N/A
	N/A
	N/A
Surveyor Notes:	N/A
N/A	N/A
	N/A
	N/A
	N/A
PROW/ADA:	N/A
Not Found, R304.5.3	N/A
•	N/A
	N/A
	N/
	IN/A

Field Measurements/Component Compliance								
Compliance Description		Data	Comp	liance D	Description	Data		
N/A	Ramp Length (in)	47.0	Yes	Ramp S	Slope (%)	5.7		
Yes	Ramp Width (in)	48.0	No	Ramp X	(Slope (%)	7.9		
N/A	Flare Type LT	N/A	N/A	Flare Ty	/pe RT	N/A		
N/A	Flare Slope LT (%)	N/A	N/A	Flare S	lope RT (%)	N/A		
N/A	Flare Traversable LT?	N/A	N/A	Flare Tr	aversable RT?	N/A		
N/A	Landing Length (in)	N/A	N/A	DWS P	rovided?	N/A		
N/A	Landing Width (in)	N/A	N/A	DWS C	ontrast?	N/A		
N/A	Landing Slope (%)	N/A	N/A	DWS L	ength (in)	N/A		
N/A	Landing X Slope (%)	N/A	N/A	DWS F	ull Width?	N/A		
N/A	Landing Curb? (Y/N)	N/A	N/A	DWS O	ffset (in)	N/A		
N/A	Shared Landing?	N/A						
N/A	Gutter Ponding?	N/A	N/A	Gutter 9	Slope (%)	N/A		
N/A	Gutter Lip Ht (in)	N/A	N/A	Gutter 2	K Slope (%)	N/A		
N/A	Painted X Walk1?	No	N/A	Painted	X Walk2?	N/A		
	X Walk 1 Direction	To N		X Walk	2 Direction	N/A		
N/A	X Walk 1 Width (in)	N/A	N/A	X Walk	2 Width (in)	N/A
