Access Compliance Report

Public Rights-of-Way

(Curb Ramps)

Intersection ID: 13085	Main Street: MORRIS_FIELD_DR	Cross Street: CAPITOL_DR	Location: S
ADA ID: 791FEE4174A2	Ramp Type: Combination2	Initial Pass/Fail: Fail	Overall Compliance: No
			Severity Score: 46.25

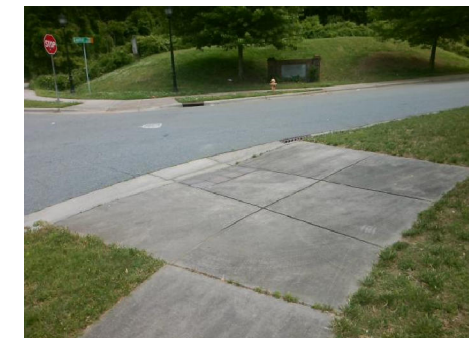
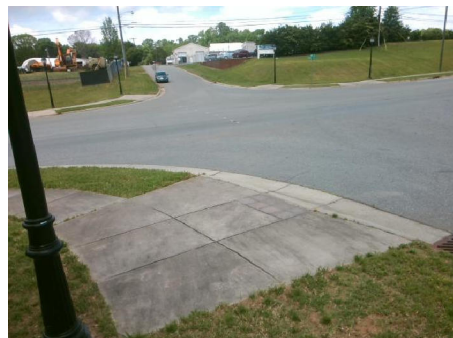
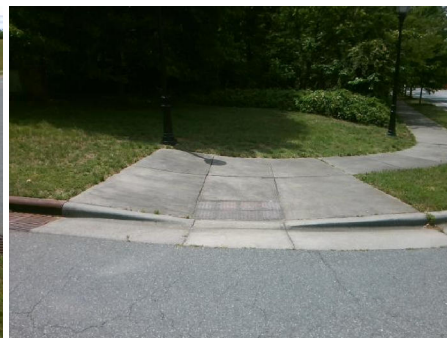
R304.5.1, R304.5.3, R304.3.2

Compliance	Description	Data	Compliance	Description	Data
N/A	Ramp Length LT (in)	61.0	N/A	Ramp Length RT (in)	N/A
Yes	Ramp Width LT (in)	72.0	N/A	Ramp Width RT (in)	N/A
No	Ramp Slope LT (%)	12.2	N/A	Ramp Slope RT (%)	N/A
No	Ramp XSlope LT (%)	2.1	N/A	Ramp XSlope RT (%)	N/A
N/A	Ramp Length (in)	72.0	Yes	Ramp Slope (%)	6.2
No	Ramp Width (in)	47.0	No	Ramp XSlope (%)	5.7
N/A	Flare Type LT	N/A	N/A	Flare Type RT	N/A
N/A	Flare Slope LT (%)	N/A	N/A	Flare Slope RT (%)	N/A
N/A	Flare Traversable LT?	N/A	N/A	Flare Traversable RT?	N/A
N/A	Landing Length (in)	N/A	N/A	DWS Provided?	N/A
N/A	Landing Width (in)	N/A	N/A	DWS Contrast?	N/A
N/A	Landing Slope (%)	N/A	N/A	DWS Length (in)	N/A
N/A	Landing X Slope (%)	N/A	N/A	DWS Full Width?	N/A
N/A	Landing Curb? (Y/N)	N/A	N/A	DWS Offset (in)	N/A
N/A	Shared Landing?	N/A			
N/A	Gutter Ponding?	N/A	N/A	Gutter Slope (%)	N/A
N/A	Gutter Lip Ht (in)	N/A	N/A	Gutter X Slope (%)	N/A
N/A	Painted X Walk1?	No	N/A	Painted X Walk2?	N/A

Remove & Replace Entire Ramp.
