# Access Compliance Report

## Public Rights-of-Way

### (Curb Ramps)

| Intersection ID: N/A | Main Street: ROCK_ISLAND_RD | Cross Street: AGNEW_DR | Location: N |

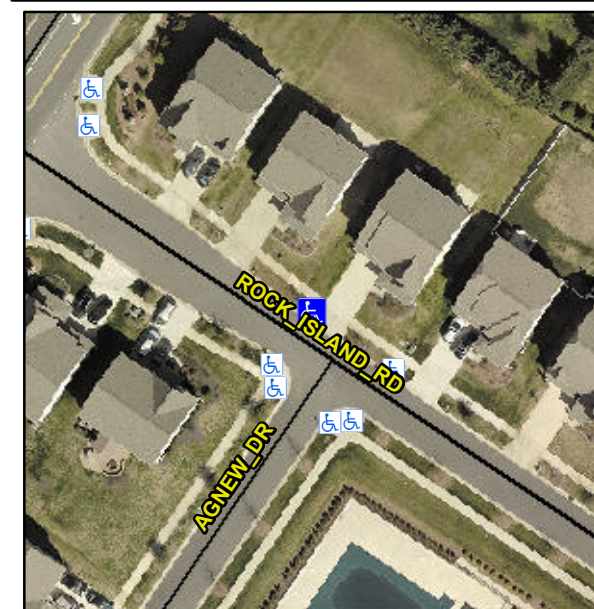
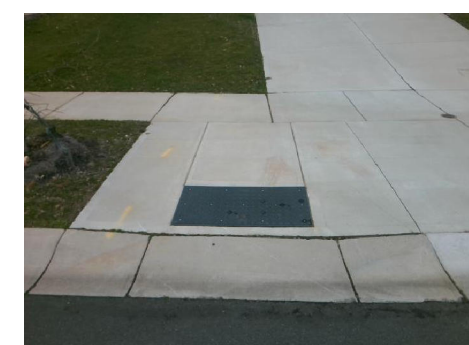
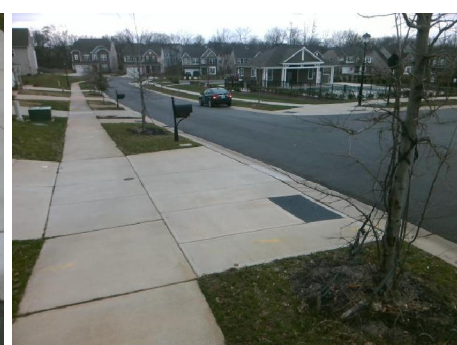
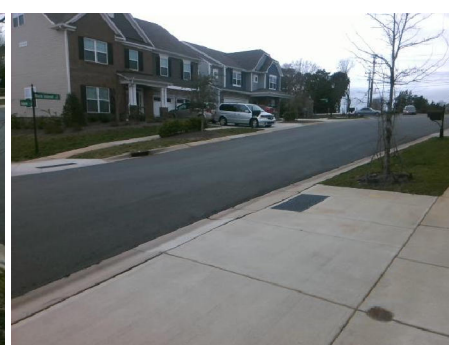
| ADA ID: 7928A26A64B5 | Ramp Type: Perp | Initial Pass/Fail: Fail | Overall Compliance: No |

**Not Found, R304.5.1, R304.5.3**

| Compliance | Description | Data | Compliance | Description | Data |
|---|---|---|---|---|---|
| N/A | Ramp Length (in) | 97.0 | Yes | Ramp Slope (%) | 5.7 |
| No | Ramp Width (in) | 45.5 | No | Ramp XSlope (%) | 8.8 |

**Remove & Replace Entire Ramp.**

Total Cost: \$ 1850.00
