# Access Compliance Report

## Public Rights-of-Way

### (Curb Ramps)

Intersection ID: N/A	Main Street: WILLIAM CALDWELL AV	Cross Street: CALDWELL RD	Location: SE
ADA ID: 79918670545C	Ramp Type: Combination2Diag	Initial Pass/Fail: Fail	Overall Compliance: No
		Severity Score: 0

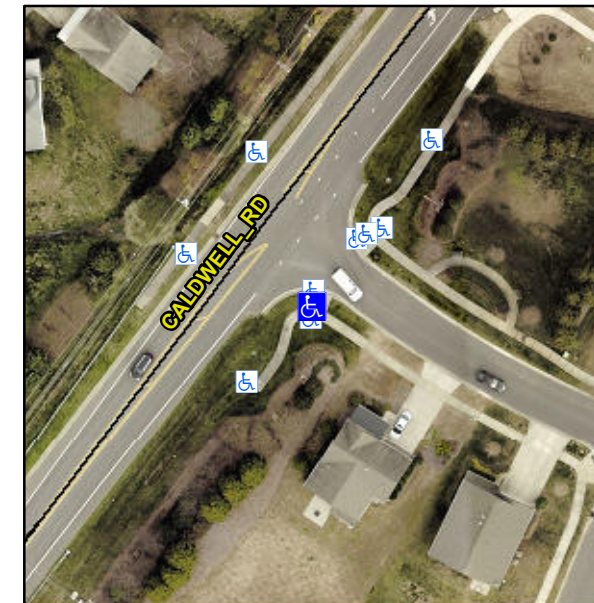
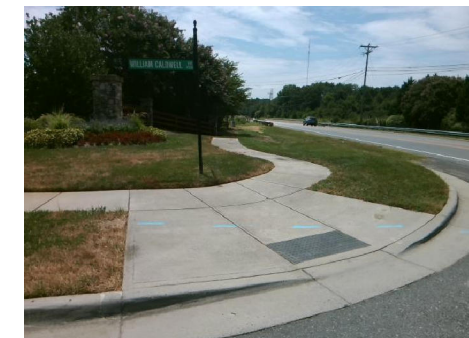
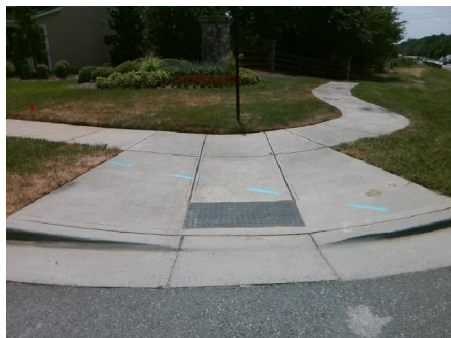
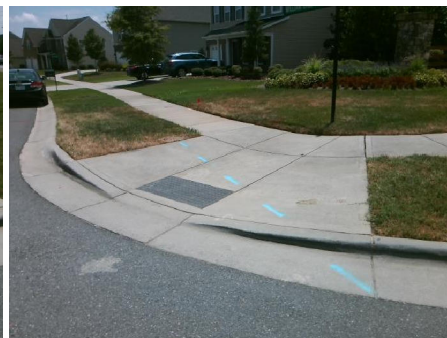
**Not Found, R304.5.1, R304.5.3, R304.3.2**

Compliance	Description	Data	Compliance	Description	Data
N/A	Ramp Length LT (in)	41.0	N/A	Ramp Length RT (in)	16.0
Yes	Ramp Width LT (in)	61.0	Yes	Ramp Width RT (in)	60.0
Yes	Ramp Slope LT (%)	0.7	No	Ramp Slope RT (%)	11.1
No	Ramp XSlope LT (%)	2.7	No	Ramp XSlope RT (%)	3.1
N/A	Ramp Length (in)	99.0	Yes	Ramp Slope (%)	3.0
No	Ramp Width (in)	47.0	No	Ramp XSlope (%)	2.4
N/A	Flare Type LT	N/A	N/A	Flare Type RT	N/A
N/A	Flare Slope LT (%)	N/A	N/A	Flare Slope RT (%)	N/A
N/A	Flare Traversable LT?	N/A	N/A	Flare Traversable RT?	N/A
N/A	Landing Length (in)	N/A	N/A	DWS Provided?	N/A
N/A	Landing Width (in)	N/A	N/A	DWS Contrast?	N/A
N/A	Landing Slope (%)	N/A	N/A	DWS Length (in)	N/A
N/A	Landing X Slope (%)	N/A	N/A	DWS Full Width?	N/A
N/A	Landing Curb? (Y/N)	N/A	N/A	DWS Offset (in)	N/A
N/A	Shared Landing?	N/A			
N/A	Gutter Ponding?	N/A	N/A	Gutter Slope (%)	N/A
N/A	Gutter Lip Ht (in)	N/A	N/A	Gutter X Slope (%)	N/A
N/A	Painted X Walk1?	No	N/A	Painted X Walk2?	No

X Walk 1 Direction	To NE		X Walk 2 Direction	To NW
	X Walk 1 Width (in)	N/A		X Walk 2 Width (in)	N/A
	X Walk 1 Slope (%)	2.4		X Walk 2 Slope (%)	3.3
	X Walk 1 X Slope (%)	2.9		X Walk 2 X Slope (%)	2.1
N/A	Ramp inside XWalk1?	N/A	N/A	Ramp inside XWalk2?	N/A
	Road Slope (%)	2.2		Clear Space?	N/A
	Road X Slope (%)	2.3	N/A	Clear Space to XWalk (in)	N/A
			N/A	Any Obstruction?	N/A
				Obstruction Type	N/A
			N/A	Storm Grate/Utility Hazard?	N/A
				Storm Grate/Utility Type	N/A
			Yes	Surface Condition? (G/P)	Good
				Curb Slope (%)	24.7

**Remove & Replace Curb Ramp With Two New Directional Ramps or Equivalent.**
