Access Compliance Report Public Rights-of-Way (Curb Ramps)

Intersection ID: 28164 Main Street: BENTON_PL Cross Street: BRYSON_BEND_DR Location: N

ADA ID: 79EC4E06EDAF Ramp Type: PerpDiag Initial Pass/Fail: Fail Overall Compliance: No Severity Score: 17.5

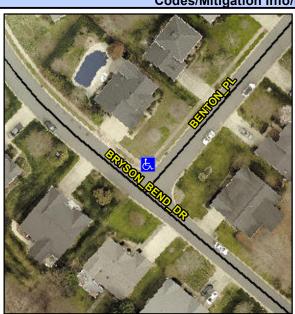
PROW/ADA:
Not Found, R304.5.1

Field Measurements/Component Compliance					
Compliance Description		Data	Comp	oliance Description	Data
N/A	Ramp Length (in)	94.5	Yes	Ramp Slope (%)	5.2
No	Ramp Width (in)	32.5	Yes	Ramp XSlope (%)	0.2
N/A	Flare Type LT	N/A	N/A	Flare Type RT	N/A
N/A	Flare Slope LT (%)	N/A	N/A	Flare Slope RT (%)	N/A
N/A	Flare Traversable LT?	N/A	N/A	Flare Traversable RT?	N/A
N/A	Landing Length (in)	N/A	N/A	DWS Provided?	N/A
N/A	Landing Width (in)	N/A	N/A	DWS Contrast?	N/A
N/A	Landing Slope (%)	N/A	N/A	DWS Length (in)	N/A
N/A	Landing X Slope (%)	N/A	N/A	DWS Full Width?	N/A
N/A	Landing Curb? (Y/N)	N/A	N/A	DWS Offset (in)	N/A
N/A	Shared Landing?	N/A			
N/A	Gutter Ponding?	N/A	N/A	Gutter Slope (%)	N/A
N/A	Gutter Lip Ht (in)	N/A	N/A	Gutter X Slope (%)	N/A
N/A	Painted X Walk1?	No	N/A	Painted X Walk2?	No
	X Walk 1 Direction	To SW		X Walk 2 Direction	To SE
N/A	X Walk 1 Width (in)	N/A	N/A	X Walk 2 Width (in)	N/A
	X Walk 1 Slope (%)	2.1		X Walk 2 Slope (%)	1.5

Remove & Replace Curb Ramp With
Two New Directional Ramps or
Equivalent.
