Access Compliance Report Public Rights-of-Way (Curb Ramps)

Intersection ID: N/AMain Street:ELGIN_MOOR_RDCross Street:LANGWELL_LNLocation:NEADA ID: 7A7FC7476FC6Ramp Type:PerpInitial Pass/Fail:FailOverall Compliance:NoSeverity Score:22.5

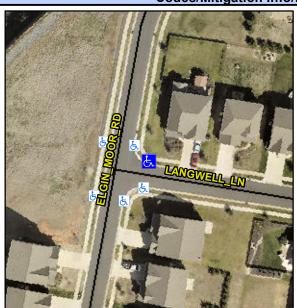
| 055ible Solution | |
|---|---|
| Not Found, R304.5.1, R304.2.2, | N |
| R304.5.3 | N |

| Field Measurements/Component Compliance | | | | | | | |
|---|---|---|---|---|---|---|--|
| N/A | Ramp Length (in) | 47.5 | No | Ramp | Slope (%) | 8.5 | |
| No | Ramp Width (in) | 47.0 | No | Ramp | XSlope (%) | 2.7 | |

| 055ible Solution | |
|---|---|
| Remove & Replace Entire Ramp. | |
