Access Compliance Report

Public Rights-of-Way

(Curb Ramps)

Intersection ID: 5758	Main Street: NEVIN_RD	Cross Street: SPANISH_MOSS_LN	Location:	N
ADA ID: 7AAFCA45B513	Ramp Type: Perp	Initial Pass/Fail: Fail	Overall Compliance: No	Severity Score: 10

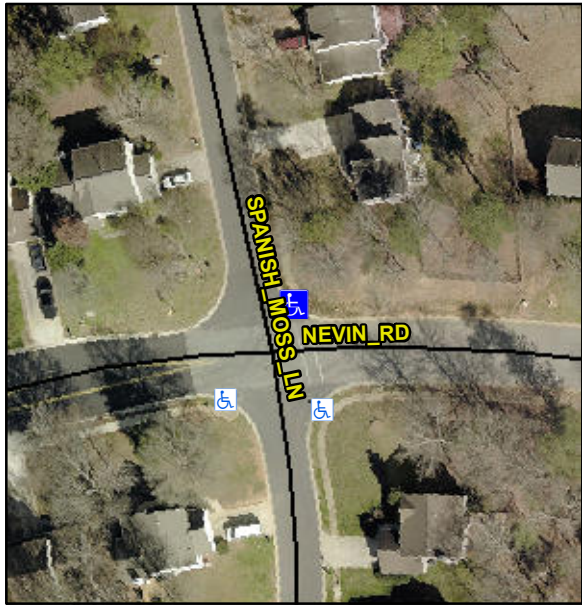
Possible Solutions:		Compliance	Description	Data	Compliance	Description	Data
	Remove & Replace Entire Ramp.		N/A	Ramp Length (in)	95.0	Yes	Ramp Slope (%)	7.4
			No	Ramp Width (in)	46.0	Yes	Ramp XSlope (%)	2.3
			N/A	Flare Type LT	N/A	N/A	Flare Type RT	N/A
			N/A	Flare Slope LT (%)	N/A	N/A	Flare Slope RT (%)	N/A
			N/A	Flare Traversable LT?	N/A	N/A	Flare Traversable RT?	N/A
			N/A	Landing Length (in)	N/A	N/A	DWS Provided?	N/A
			N/A	Landing Width (in)	N/A	N/A	DWS Contrast?	N/A
			N/A	Landing Slope (%)	N/A	N/A	DWS Length (in)	N/A
			N/A	Landing X Slope (%)	N/A	N/A	DWS Full Width?	N/A
Surveyor Notes:			N/A	Landing Curb? (Y/N)	N/A	N/A	DWS Offset (in)	N/A
N/A			N/A	Shared Landing?	N/A			
PROW/ADA:			N/A	Gutter Ponding?	N/A	N/A	Gutter Slope (%)	N/A
Not Found, R304.5.1			N/A	Gutter Lip Ht (in)	0.75	N/A	Gutter X Slope (%)	N/A
