# Access Compliance Report

## Public Rights-of-Way

### (Curb Ramps)

| Intersection ID: 12342 | Main Street: E_8TH_ST | Cross Street: N_CALDWELL_ST | Location: E |

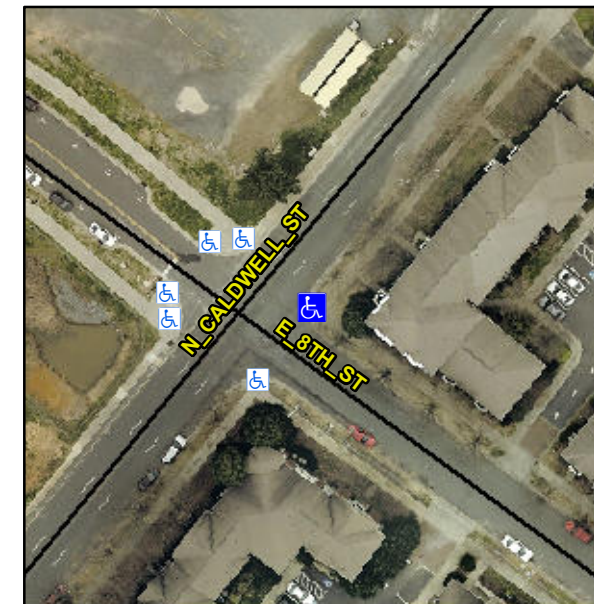
**Not Found, R304.2.2**

| Compliance | Description | Data | Compliance | Description | Data |
|---|---|---|---|---|---|
| N/A | Ramp Length (in) | 46.0 | No | Ramp Slope (%) | 8.7 |

**Remove & Replace Curb Ramp With Two New Directional Ramps or Equivalent.**
