## **Access Compliance Report Public Rights-of-Way** (Curb Ramps)

Intersection ID: 6524 Main Street: LINDA LOU CT Cross Street: OREN\_THOMPSON\_RD Location: NE **ADA ID: 7B217FE24FD7** Ramp Type: Directional1 Initial Pass/Fail: Fail **Overall Compliance: No Severity Score:** 10

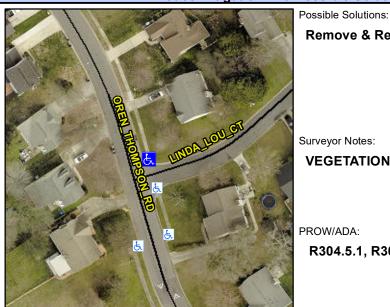
**LINDA LOU CT** Street 1 Name Stop Condition-Street 1 StopSign Street 2 Name N/A Stop Condition-Street 2 N/A Surveyor Notes: **VEGETATION OVERGROWTH** PROW/ADA: R304.5.1, R304.5.3

Field Measurements/Component Compliance					
Compliance Description		Data	Compl	iance Description	Data
N/A	Ramp Length (in)	46.0	N/A	Grade Break?	N/A
No	Ramp Width (in)	44.0	N/A	Grade Break Slope (%)	0.0
Yes	Ramp Slope (%)	5.5	N/A	Grade Break XSlope (%)	0.0
No	Ramp XSlope (%)	3.0			
N/A	Flare Type LT	N/A	N/A	Flare Type RT	N/A
N/A	Flare Slope LT (%)	N/A	N/A	Flare Slope RT (%)	0.0
N/A	Flare Traversable LT?	N/A	N/A	Flare Traversable RT?	N/A
N/A	Landing Length (in)	0.0	N/A	DWS Provided?	N/A
N/A	Landing Width (in)	0.0	N/A	DWS Contrast?	N/A
N/A	Landing Slope (%)	0.0	N/A	DWS Length (in)	N/A
N/A	Landing X Slope (%)	0.0	N/A	DWS Full Width?	N/A
N/A	Landing Curb? (Y/N)	N/A	N/A	DWS Offset LT (in)	N/A
N/A	Shared Landing?	N/A	N/A	DWS Offset RT (in)	N/A
N/A	Gutter Ponding?	0.0	N/A	Gutter Slope (%)	N/A
N/A	Gutter Lip Ht (in)	0.0	N/A	Gutter X Slope (%)	N/A
N/A	Painted X Walk1?	No		Road Slope (%)	1.3
	X Walk 1 Direction	To S		Road X Slope (%)	1.1

X Walk 1 Width (in)	N/A		Clear Space?	N/A
	X Walk 1 Slope (%)	1.3	N/A	Clear Space to XWalk (in)	N/A
	X Walk 1 X Slope (%)	1.1	N/A	Storm Grate/Utility Hazard?	N/A
N/A	Ramp inside XWalk1?	N/A		Storm Grate/Utility Type	
N/A	Any Obstructions?	N/A			N/A
	Obstruction Type		Yes	Surface Condition? (G/P)	Good
		N/A	N/A	Curb Slope (%)	11.8

Remove & Replace Entire Ramp.
