Access Compliance Report

Public Rights-of-Way

(Curb Ramps)

| Intersection ID: 48516 | Main Street: GALLERIA CLUB LN | Cross Street: GALLERIA BV | Location: NE |

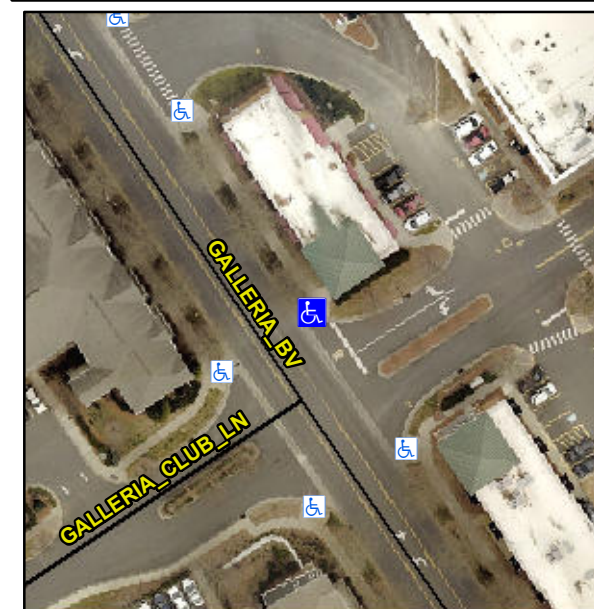
| ADA ID: 7BA80AC224E7 | Ramp Type: PerpDiag | Initial Pass/Fail: Fail | Overall Compliance: No |
| Severity Score: 35 | | | |

R304.5.1

| Compliance | Description | Data | Compliance | Description | Data |
|---|---|---|---|---|---|
| No | Ramp Width (in) | 30.0 | Yes | Ramp XSlope (%) | 1.2 |

Remove & Replace Curb Ramp With Two New Directional Ramps or Equivalent.

Total Cost: \$ 3200.00
