Access Compliance Report Public Rights-of-Way (Curb Ramps)

Intersection ID: N/A Main Street: E_MARTIN_LUTHER_KING_JR_CBVss Street: S_COLLEGE_ST Location:

ADA ID: 7BE6AF39E3BD Ramp Type: PerpDiag Initial Pass/Fail: Fail **Overall Compliance: No** Severity Score: 33.75

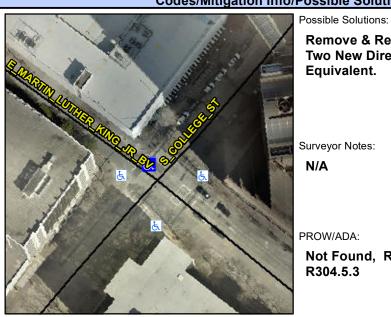
Not Found, R304.5.1 R304.5.3

Field Measurements/Component Compliance							
Comp	liance Description	Data	Comp	oliance Description	Data		
N/A	Ramp Length (in)	72.0	No	Ramp Slope (%)	9.4		
No	Ramp Width (in)	45.0	No	Ramp XSlope (%)	5.1		
N/A	Flare Type LT	N/A	N/A	Flare Type RT	N/A		
N/A	Flare Slope LT (%)	N/A	N/A	Flare Slope RT (%)	N/A		
N/A	Flare Traversable LT?	N/A	N/A	Flare Traversable RT?	N/A		
N/A	Landing Length (in)	N/A	N/A	DWS Provided?	N/A		
N/A	Landing Width (in)	N/A	N/A	DWS Contrast?	N/A		
N/A	Landing Slope (%)	N/A	N/A	DWS Length (in)	N/A		
N/A	Landing X Slope (%)	N/A	N/A	DWS Full Width?	N/A		
N/A	Landing Curb? (Y/N)	N/A	N/A	DWS Offset (in)	N/A		
N/A	Shared Landing?	N/A					
N/A	Gutter Ponding?	N/A	N/A	Gutter Slope (%)	N/A		
N/A	Gutter Lip Ht (in)	N/A	N/A	Gutter X Slope (%)	N/A		
N/A	Painted X Walk1?	Yes	N/A	Painted X Walk2?	Yes		
	X Walk 1 Direction	To SW		X Walk 2 Direction	To SE		
N/A	X Walk 1 Width (in)	101.0	N/A	X Walk 2 Width (in)	114.0

X Walk 1 Slope (%)	1.9		X Walk 2 Slope (%)	5.4		
	X Walk 1 X Slope (%)	3.7		X Walk 2 X Slope (%)	3.3		
N/A	Ramp inside XWalk1?	Yes	N/A	Ramp inside XWalk2?	Yes		
	Road Slope (%)	3.2	N/A	Clear Space?	N/A		
	Road X Slope (%)	0.2	N/A	Clear Space to XWalk (in)	N/A		
N/A	Any Obstructions?	N/A	N/A	Storm Grate/Utility Hazard?	N/A		
	Obstruction Type			Storm Grate/Utility Type			
		N/A			N/A		
			Yes	Surface Condition? (G/P)	Good

E MARTIN LUTHER KING JR BV Street 1 Name Stop Condition-Street 2 Signal Street 2 Name S COLLEGE ST Stop Condition-Street 1 Signal Remove & Replace Curb Ramp With **Two New Directional Ramps or** Equivalent.

Total Cost:	\$ 3200.00
