# Access Compliance Report

## Public Rights-of-Way

### (Curb Ramps)

Intersection ID: 30333	Main Street: NORTHPARK_MALL_DR	Cross Street: EASTWAY_DR	Location: SW
ADA ID: 7C9B2017F269	Ramp Type: Combination1	Initial Pass/Fail: Pass	Overall Compliance: No
Codes/Mitigation Info/Possible Solution		Field Measurements/Component Compliance	
Severity Score: 7.5

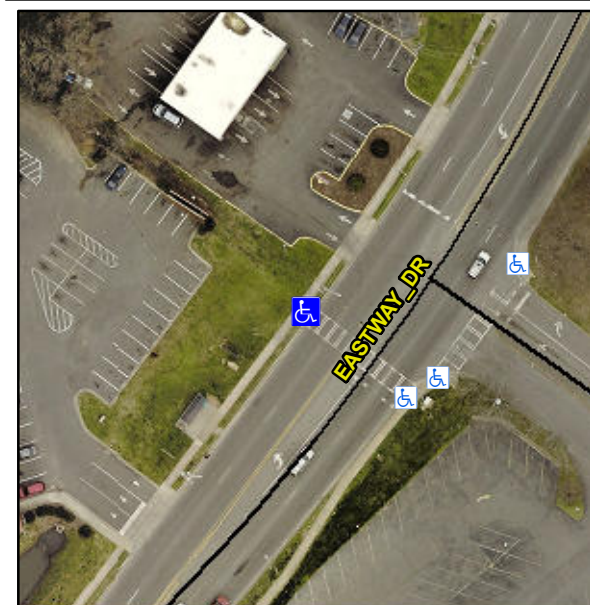
**LT RP < 5%**

**Not Found, R302.7.2**

Compliance	Description	Data	Compliance	Description	Data
N/A	Ramp Length LT (in)	70.0	N/A	Ramp Length RT (in)	71.0
Yes	Ramp Width LT (in)	58.0	Yes	Ramp Width RT (in)	58.0
Yes	Ramp Slope LT (%)	3.0	Yes	Ramp Slope RT (%)	7.5
Yes	Ramp XSlope LT (%)	0.3	Yes	Ramp XSlope RT (%)	1.1
N/A	Ramp Length (in)	42.0	Yes	Ramp Slope (%)	4.3
Yes	Ramp Width (in)	48.0	Yes	Ramp XSlope (%)	0.0
N/A	Flare Type LT	Sloped	N/A	Flare Type RT	Sloped
Yes	Flare Slope LT (%)	3.7	Yes	Flare Slope RT (%)	8.4
N/A	Flare Traversable LT?	Yes	N/A	Flare Traversable RT?	Yes
Yes	Landing Length (in)	59.0	Yes	DWS Provided?	Yes
Yes	Landing Width (in)	48.0	Yes	DWS Contrast?	Yes
Yes	Landing Slope (%)	1.7	Yes	DWS Length (in)	24.0
Yes	Landing X Slope (%)	0.1	Yes	DWS Full Width?	Yes
N/A	Landing Curb? (Y/N)	No	Yes	DWS Offset (in)	0.0
N/A	Shared Landing?	No			
Yes	Gutter Ponding?	No	Yes	Gutter Slope (%)	0.9
No	Gutter Lip Ht (in)	0.5	Yes	Gutter X Slope (%)	0.0

**Remove & Replace Entire Ramp.**

Total Cost: \$ 1800.00

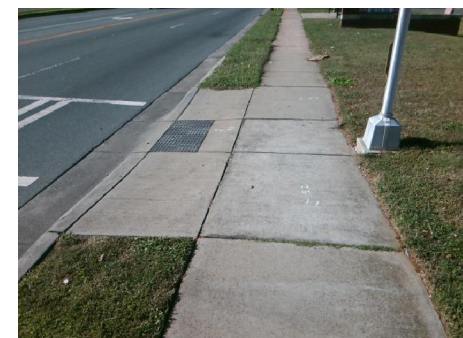
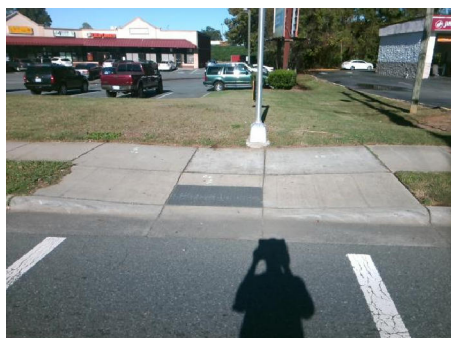
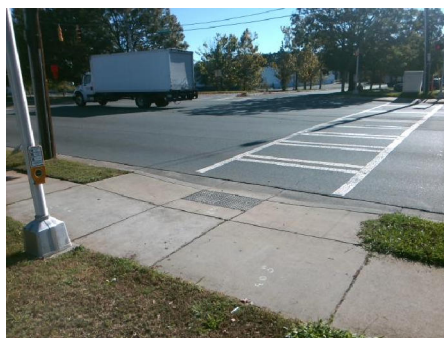
N/A	Painted X Walk1?	Yes	N/A	Painted X Walk2?	N/A
	X Walk 1 Direction	To SE		X Walk 2 Direction	N/A
	X Walk 1 Width (in)	111.0		X Walk 2 Width (in)	N/A
	X Walk 1 Slope (%)	2.3		X Walk 2 Slope (%)	N/A
	X Walk 1 X Slope (%)	1.2		X Walk 2 X Slope (%)	N/A
Yes	Ramp inside XWalk1?	Yes	N/A	Ramp inside XWalk2?	N/A
	Road Slope (%)	N/A		Clear Space?	Yes
	Road X Slope (%)	N/A	N/A	Clear Space to XWalk (in)	N/A
			Yes	Any Obstruction?	No
				Obstruction Type	N/A
			Yes	Storm Grate/Utility Hazard?	No
				Storm Grate/Utility Type	N/A
			Yes	Surface Condition? (G/P)	Good
				Curb Slope (%)	6.4
