Access Compliance Report

Public Rights-of-Way

(Curb Ramps)

Intersection ID: 15603	Main Street: MARNEY_AV	Cross Street: OAK_ARBOR_LN	Location: NW
ADA ID: 7CB05BB71AA9	Ramp Type: PerpDiag	Initial Pass/Fail: Fail	Overall Compliance: No
		Severity Score: 10

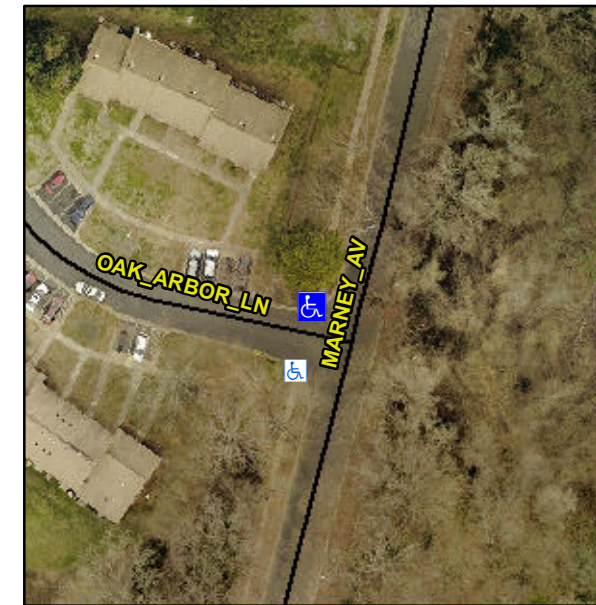
Not Found, R304.5.1, R304.5.3

Compliance	Description	Data	Compliance	Description	Data
N/A	Ramp Length (in)	100.0	Yes	Ramp Slope (%)	6.3
No	Ramp Width (in)	42.5	No	Ramp XSlope (%)	4.0
N/A	Flare Type LT	N/A	N/A	Flare Type RT	N/A
N/A	Flare Slope LT (%)	N/A	N/A	Flare Slope RT (%)	N/A
N/A	Flare Traversable LT?	N/A	N/A	Flare Traversable RT?	N/A
N/A	Landing Length (in)	N/A	N/A	DWS Provided?	N/A
N/A	Landing Width (in)	N/A	N/A	DWS Contrast?	N/A
N/A	Landing Slope (%)	N/A	N/A	DWS Length (in)	N/A
N/A	Landing X Slope (%)	N/A	N/A	DWS Full Width?	N/A
N/A	Landing Curb? (Y/N)	N/A	N/A	DWS Offset (in)	N/A
N/A	Shared Landing?	N/A			
N/A	Gutter Ponding?	N/A	N/A	Gutter Slope (%)	N/A
N/A	Gutter Lip Ht (in)	N/A	N/A	Gutter X Slope (%)	N/A
N/A	Painted X Walk1?	No	N/A	Painted X Walk2?	No
	X Walk 1 Direction	To SW		X Walk 2 Direction	To E
N/A	X Walk 1 Width (in)	N/A	N/A	X Walk 2 Width (in)	N/A
	X Walk 1 Slope (%)	2.8		X Walk 2 Slope (%)	3.6
	X Walk 1 X Slope (%)	2.3		X Walk 2 X Slope (%)	2.1

Remove & Replace Curb Ramp With Two New Directional Ramps or Equivalent.
