# Access Compliance Report

## Public Rights-of-Way

### (Curb Ramps)

Intersection ID: 9177	Main Street: MARIETTA_ST	Cross Street: KALYNNE_ST	Location:	S
ADA ID: 7CB626004C9D	Ramp Type: Perp	Initial Pass/Fail: Fail	Overall Compliance: No	Severity Score: 35

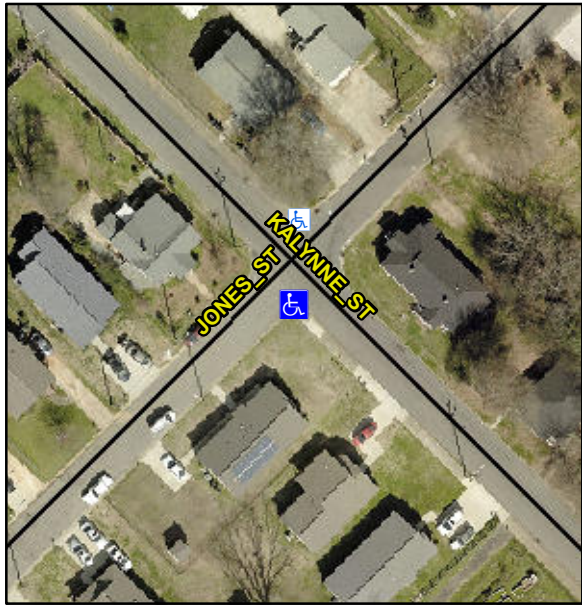
Possible Solutions:		<b>Compliance</b>			<b>Description</b>			<b>Data</b>			
	<b>Remove &amp; Replace Entire Ramp.</b>		<b>N/A</b>	Ramp Length (in)		<b>55.0</b>		<b>No</b>	Ramp Slope (%)		<b>17.1</b>	
			<b>No</b>	Ramp Width (in)		<b>46.0</b>		<b>No</b>	Ramp XSlope (%)		<b>2.4</b>	
			<b>N/A</b>	Flare Type LT		<b>N/A</b>		<b>N/A</b>	Flare Type RT		<b>N/A</b>	
			<b>N/A</b>	Flare Slope LT (%)		<b>N/A</b>		<b>N/A</b>	Flare Slope RT (%)		<b>N/A</b>	
			<b>N/A</b>	Flare Traversable LT?		<b>N/A</b>		<b>N/A</b>	Flare Traversable RT?		<b>N/A</b>	
			<b>N/A</b>	Landing Length (in)		<b>N/A</b>		<b>N/A</b>	DWS Provided?		<b>N/A</b>	
			<b>N/A</b>	Landing Width (in)		<b>N/A</b>		<b>N/A</b>	DWS Contrast?		<b>N/A</b>	
			<b>N/A</b>	Landing Slope (%)		<b>N/A</b>		<b>N/A</b>	DWS Length (in)		<b>N/A</b>	
			<b>N/A</b>	Landing X Slope (%)		<b>N/A</b>		<b>N/A</b>	DWS Full Width?		<b>N/A</b>

Surveyor Notes:		<b>N/A</b>			<b>N/A</b>			DWS Offset (in)			<b>N/A</b>	
PROW/ADA:		<b>Not Found, R304.5.1, R304.2.2, R304.5.3</b>			<b>N/A</b>							
					<b>N/A</b>			Gutter Ponding?			<b>Yes</b>	
					<b>N/A</b>			Gutter Lip Ht (in)			<b>N/A</b>	
					<b>N/A</b>			Painted X Walk1?			<b>No</b>	
					<b>To N</b>			X Walk 2 Direction			<b>N/A</b>	
					<b>N/A</b>			X Walk 2 Width (in)			<b>N/A</b>	
					<b>4.3</b>			X Walk 2 Slope (%)			<b>N/A</b>	
					<b>4.1</b>			X Walk 2 X Slope (%)			<b>N/A</b>	
					<b>N/A</b>			Ramp inside XWalk2?			<b>N/A</b>	
					<b>4.1</b>			Clear Space?			<b>N/A</b>	
					<b>4.3</b>			Clear Space to XWalk (in)			<b>N/A</b>	
					<b>N/A</b>			Storm Grate/Utility Hazard?			<b>N/A</b>	
								Storm Grate/Utility Type				
					<b>N/A</b>						<b>N/A</b>	
								Surface Condition? (G/P)			<b>Good</b>	
Total Cost:		\$ 1850.00
