# Access Compliance Report

## Public Rights-of-Way

### (Curb Ramps)

| Intersection ID: 44158 | Main Street: MEADOW_KNOLL_DR | Cross Street: FEATHER_BEND_CT | Location: SW |

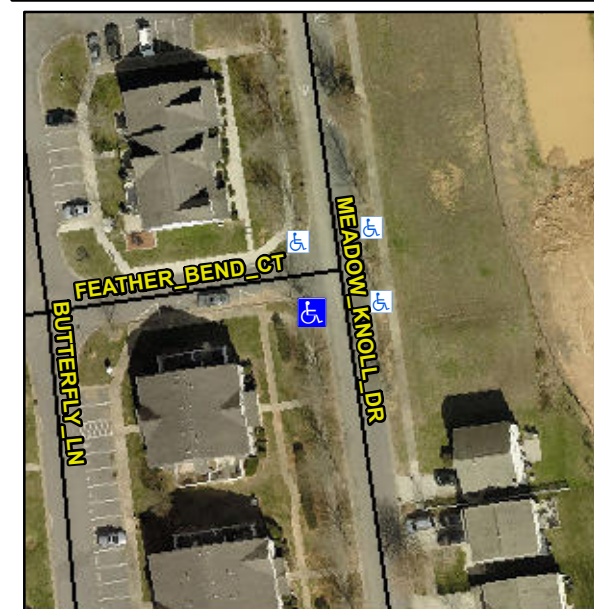
| ADA ID: 7CBE8FAB2848 | Ramp Type: PerpDiag | Initial Pass/Fail: Fail | Overall Compliance: No |

**Not Found, R304.5.1, R304.2.2, R304.5.3**

| Compliance | Description | Data | Compliance | Description | Data |
|---|---|---|---|---|---|
| N/A | Ramp Length (in) | 87.5 | No | Ramp Slope (%) | 10.7 |
| No | Ramp Width (in) | 44.0 | No | Ramp XSlope (%) | 3.6 |

**Remove & Replace Curb Ramp With Two New Directional Ramps or Equivalent.**
